# Evaluation of the Chestnut Street Art Shelters

# Chestnut & 12<sup>th</sup> St. Shelter

**NORTHEAST FENCE & IRON WORKS, INC.**

**Re: Condition assessment and treatment recommendations for the 12<sup>th</sup> Street Bus Shelter Artwork**

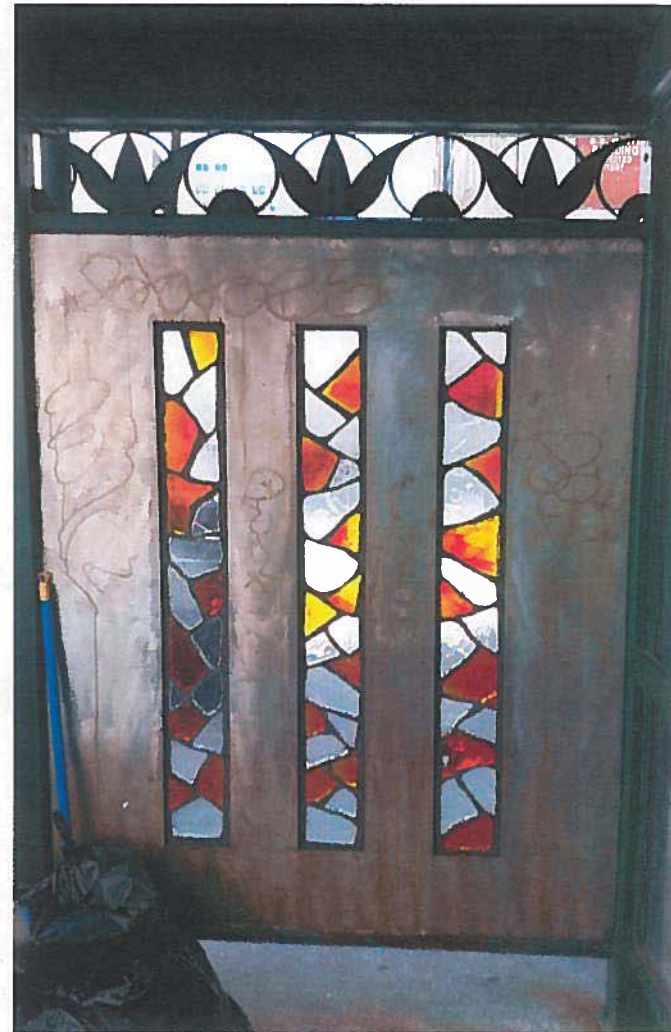
Typical condition of the Art Shelters

**Staining**

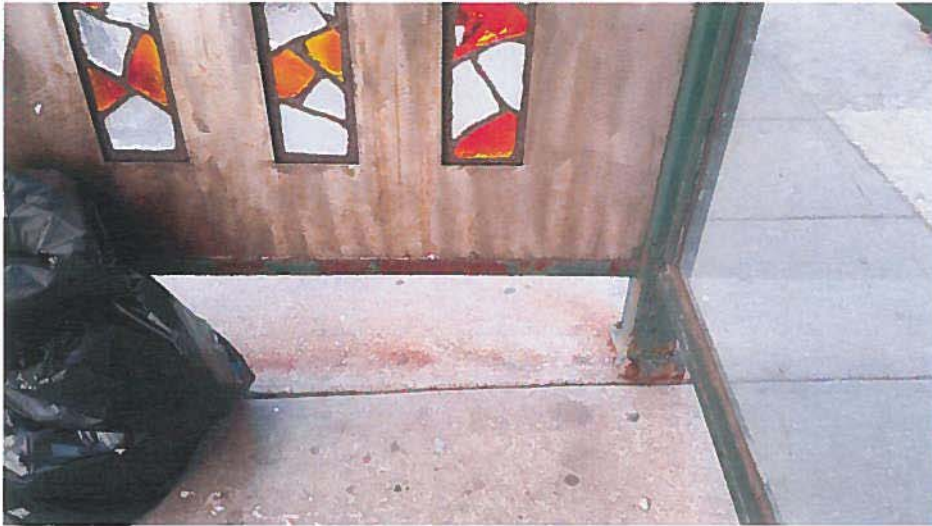
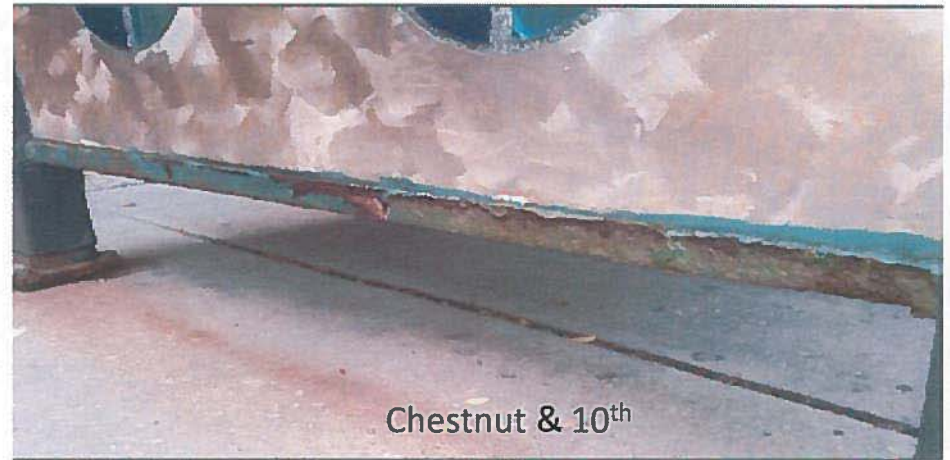
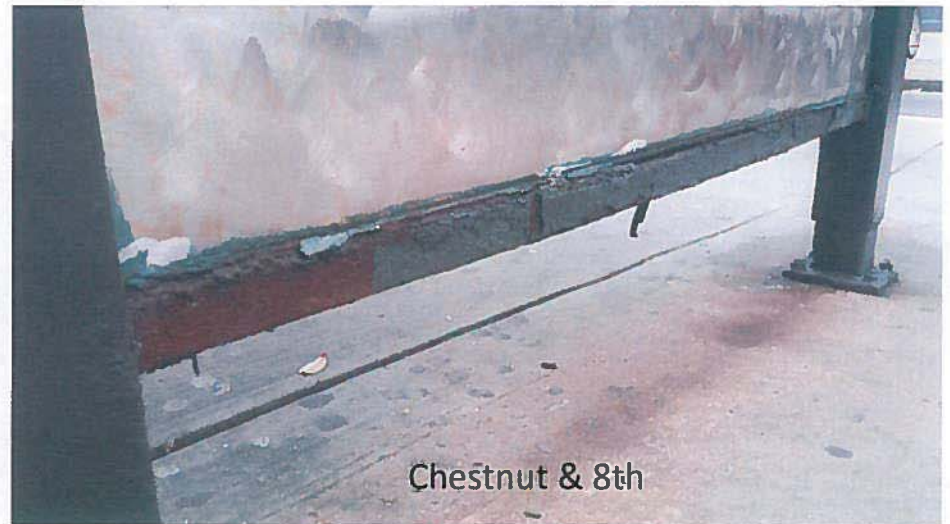
## Chestnut & 12<sup>th</sup> Base beam corrosion

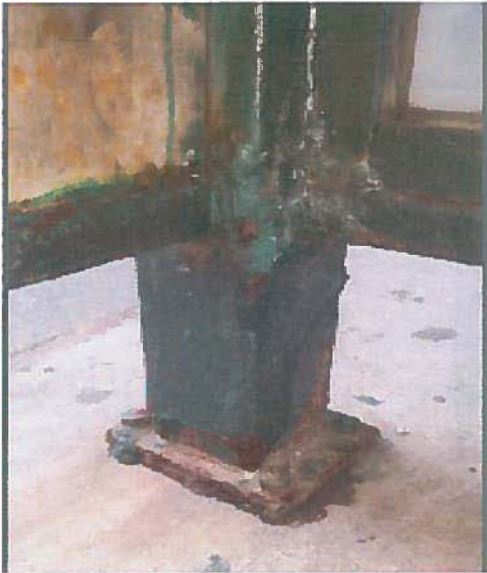
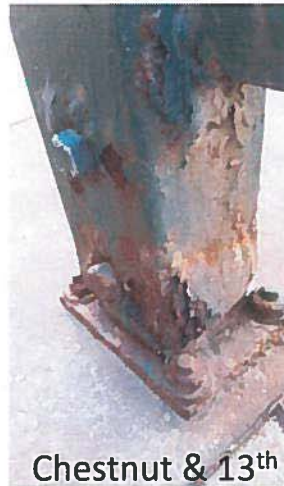
## Chestnut & 12<sup>th</sup> Leg Support Rusting

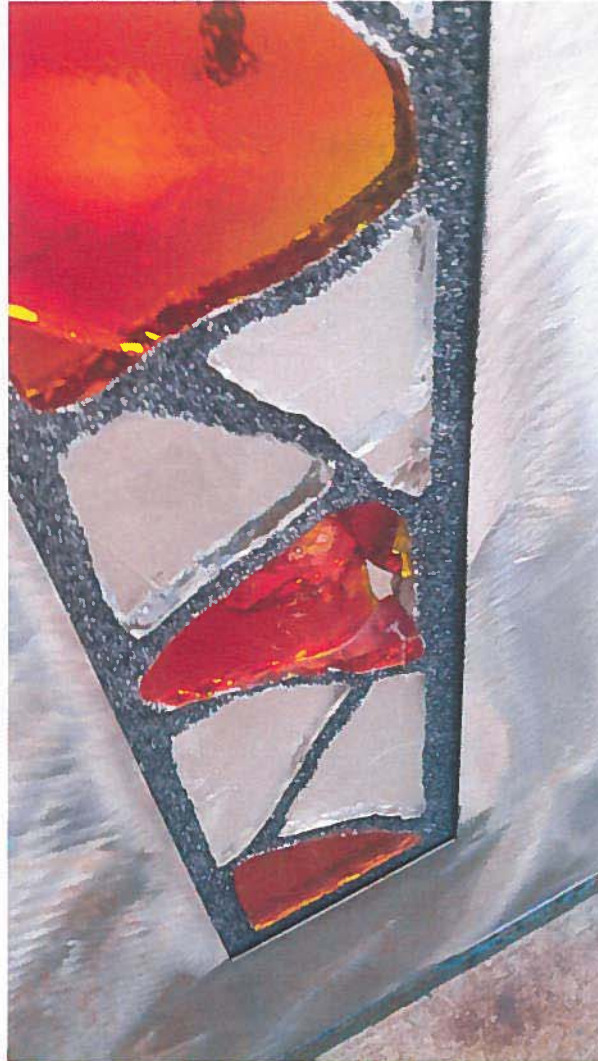
Chestnut & 12<sup>th</sup>  
Broken mosaic  
glass

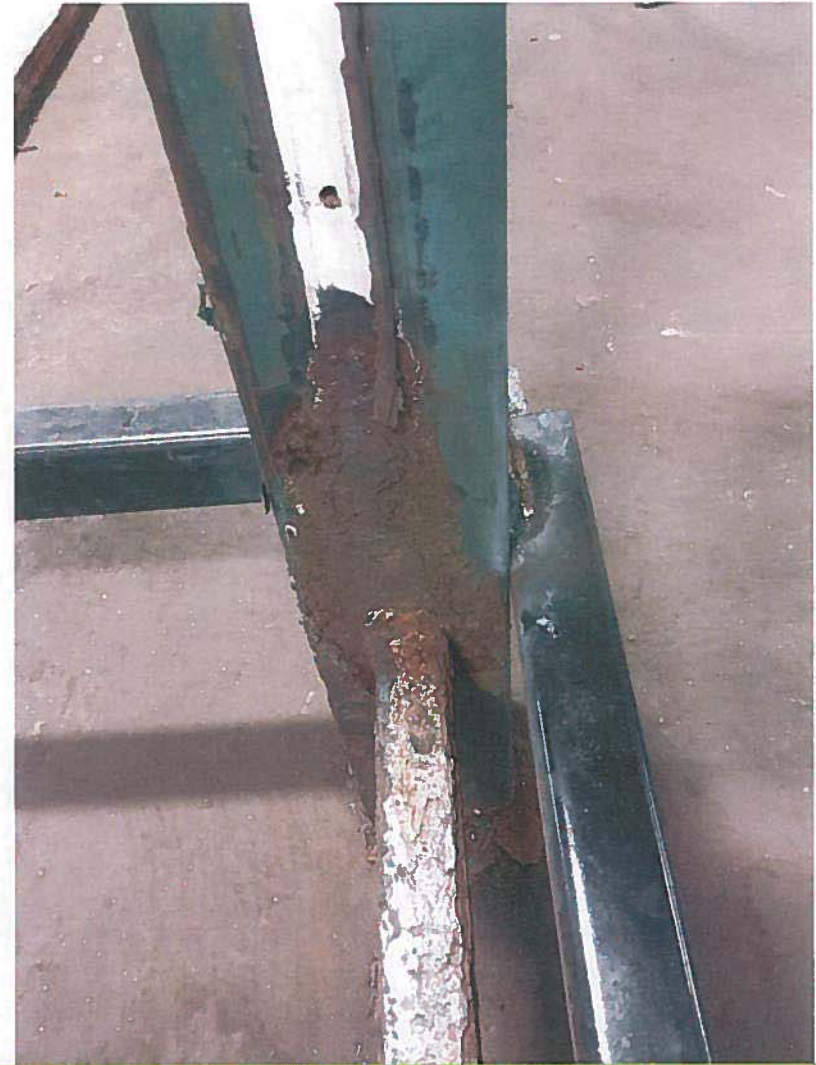
***Severe Rusting of base leg support  
columns***

The four main support columns were filled with water, rust and debris. See attached pictures of column bases.

The main support structure should be replaced due to rusting and should be fabricated from either galvanized steel or stainless steel to remedy the possibility of structural failure. The existing drainage design has failed and is basically just allowing water to completely fill the structural support columns. This should be remedied via column drainage holes and elbows being placed in the drainage tube bases allowing for proper water run-off.

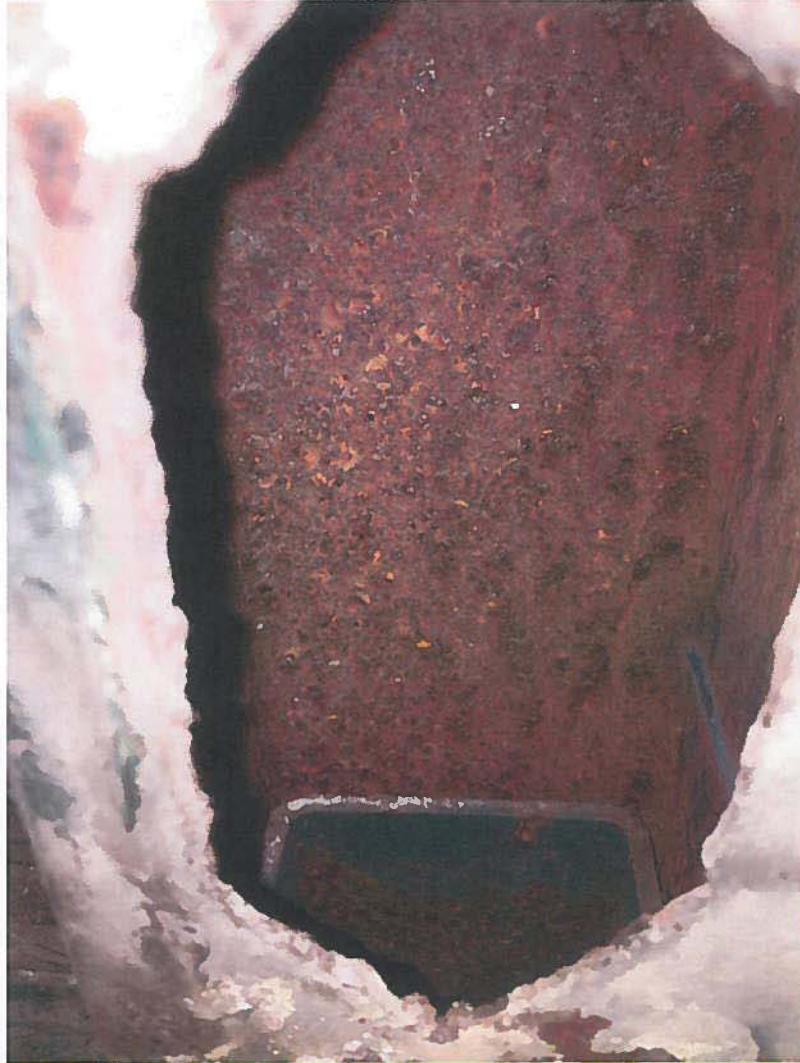
***Rusting of weep  
holes allowed for  
water and debris  
to fill legs***

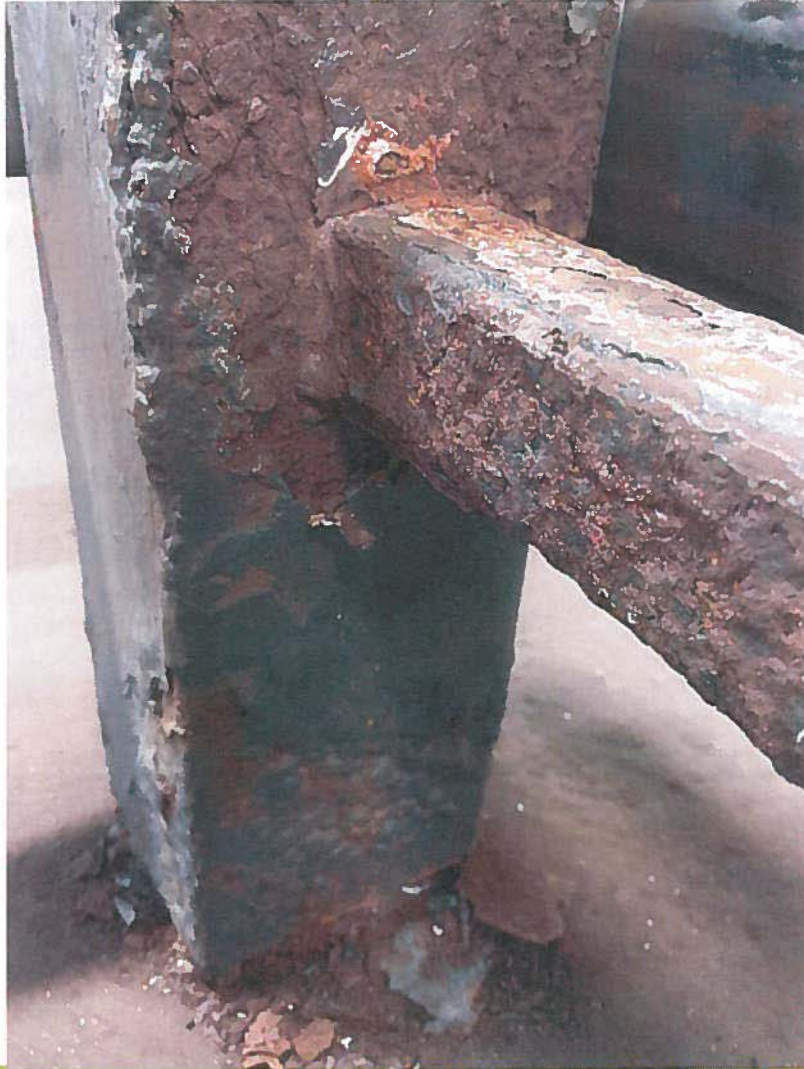
***Severe Rusting of stained glass panel  
support beam***

***Stained glass panels weigh 250-300 lbs***

**Conclusion: The corrosion of the base beam could lead to failure of the beam. The failure of the beam would leave the 250-300 lb mosaic art panel unsupported. The risk associated with the beam failure and art panel destabilization is a public safety hazard.**

The stainless steel paneling holding the stained glass was filled with water due to no caulking being applied which in turn thoroughly rusted the associated support base. This should be of concern at all shelters as these panels weigh between 250-300 pounds and may cause serious bodily injury once failure occurs.

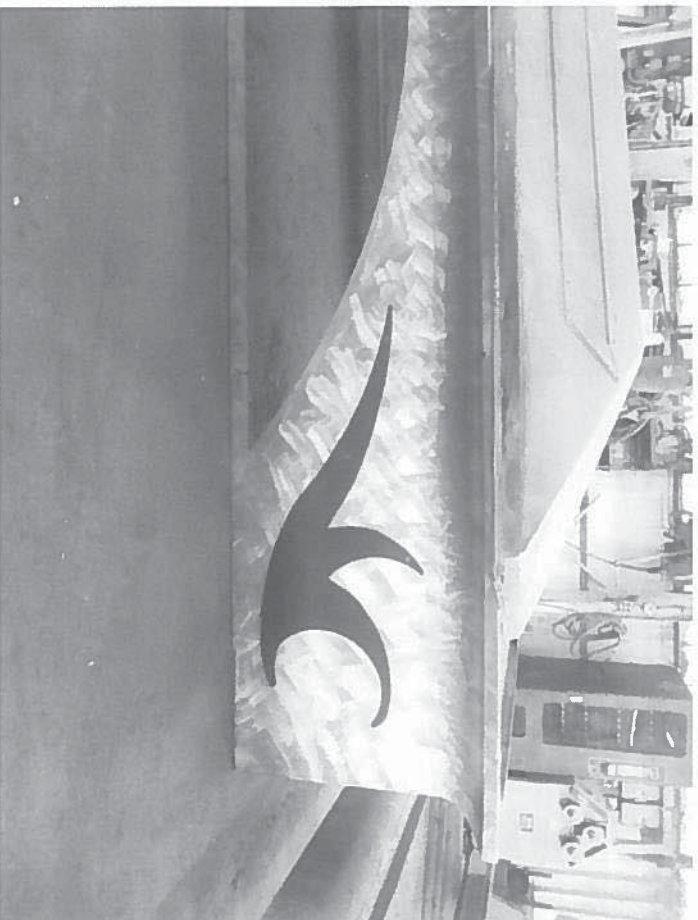
**Condition:** The cap is generally in good condition but the painted finish on the north side detailing is chalking. The stainless steel is soiled but in good condition.

*The edge of the cap and a detail of the scroll detailing*

**Treatment:** Clean the surface to remove soiling. Remove the paint finish to prepare the surface for refinishing. Apply a high-performance paint system including a rust-inhibiting primer and two-coats of finish paint.

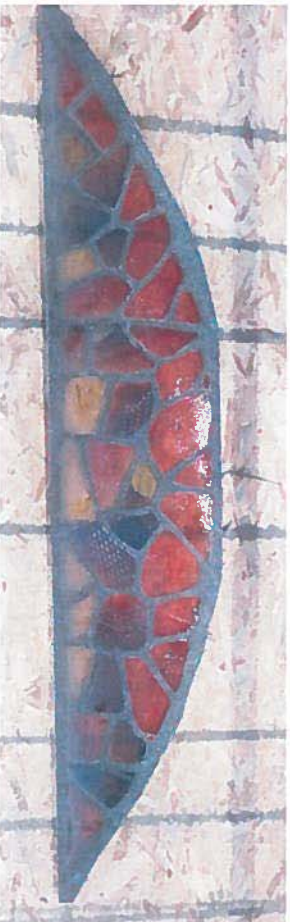
**Condition:** The glass and embedment material are soiled. The glass is cracked in some areas, but this appears to be an intentional aesthetic.

*Fanlight – note the discoloration due to soiling at the base*

**Treatment:** Clean soiling from the glass and the embedment material.

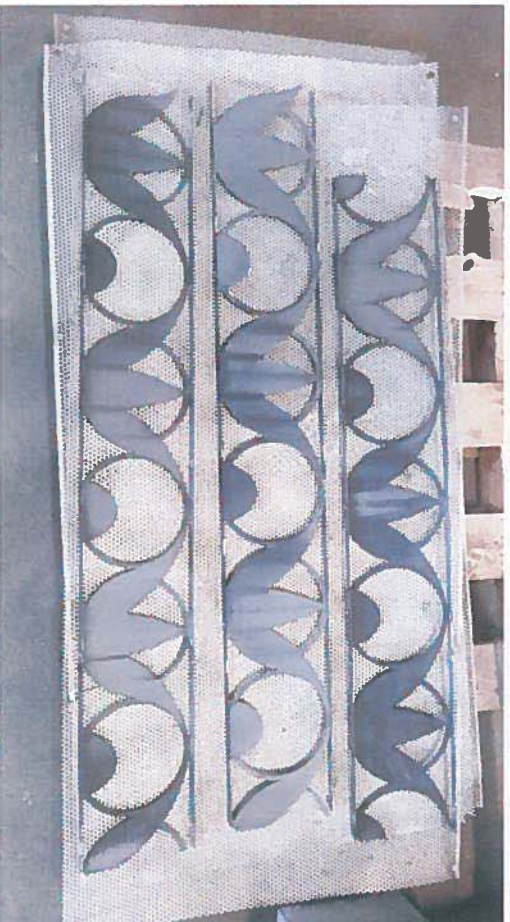
**Condition:** The scrolls are in good condition but the paint finish is chalking and discolored.

*Scrolled dividers exhibiting chalking paint*

**Treatment:** Remove the paint to prepare the surface for refinishing. Apply a high-performance paint system including a rust-inhibiting primer and two coats of finish paint.

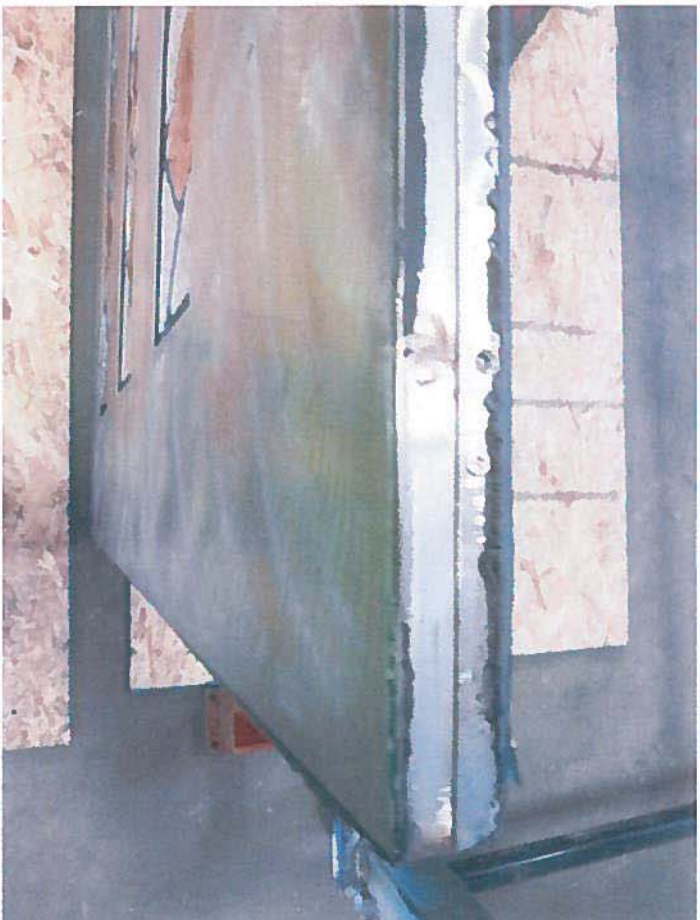
**Condition:** The artwork is in generally good condition. The sealant at the joints between the bus shelter structure and the art work has failed. The east base rail of the structure exhibits corrosion where it intersects with the panel, the result of moisture becoming trapped at this location.

*Edge of the panel with deteriorated sealant*

**Treatment:** Install drainage weeps between the panel and the bottom rail of the structure. Prior to reinstalling the artwork, clean all old deteriorated sealant from the edges of the artwork and the structure and install new sealant.

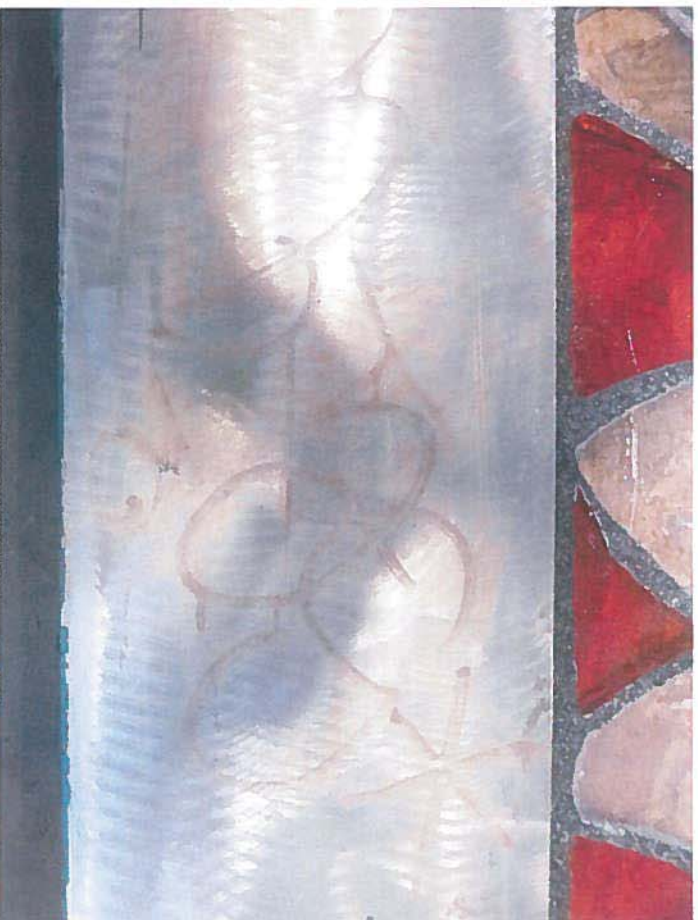
**Condition:** Substantial areas of the metal surface have halos of old graffiti. The glass and embedment material for the glass is soiled. There is cracked, broken and missing glass in one section. Other areas also have cracked glass but this appears to be an intentional aesthetic. There are no noticeable problems on the exterior of the panel. The interior was not accessible.

*Grffiti*

**Treatment:** Remove graffiti with a chemical cleaning solution. If etching of the surface is discovered, resurface the metalwork.  
Replace the damaged piece of glass with matching material.  
Clean soiling from the glass and embedment material.  
Clean the edges of the panel of all old sealant material.

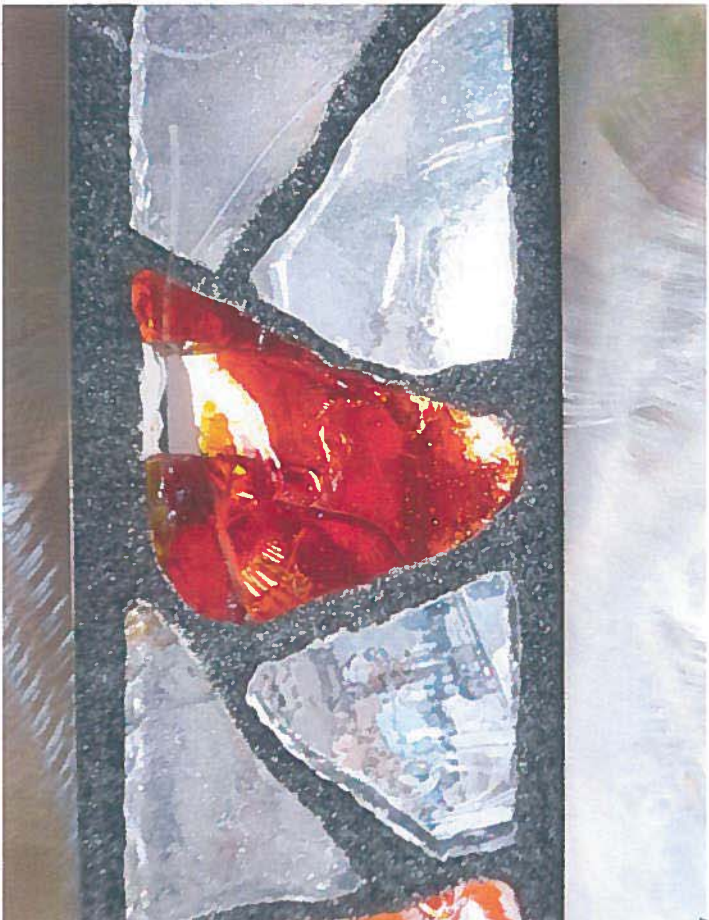
*Broken glass unit*
