Pennsylvania  
Horticultural  
Society

## Phase IB Archaeological Investigations of the Mother Bethel Burying Ground, 1810 – Circa 1864

ER No. 2013-1516-101-A

**URS**

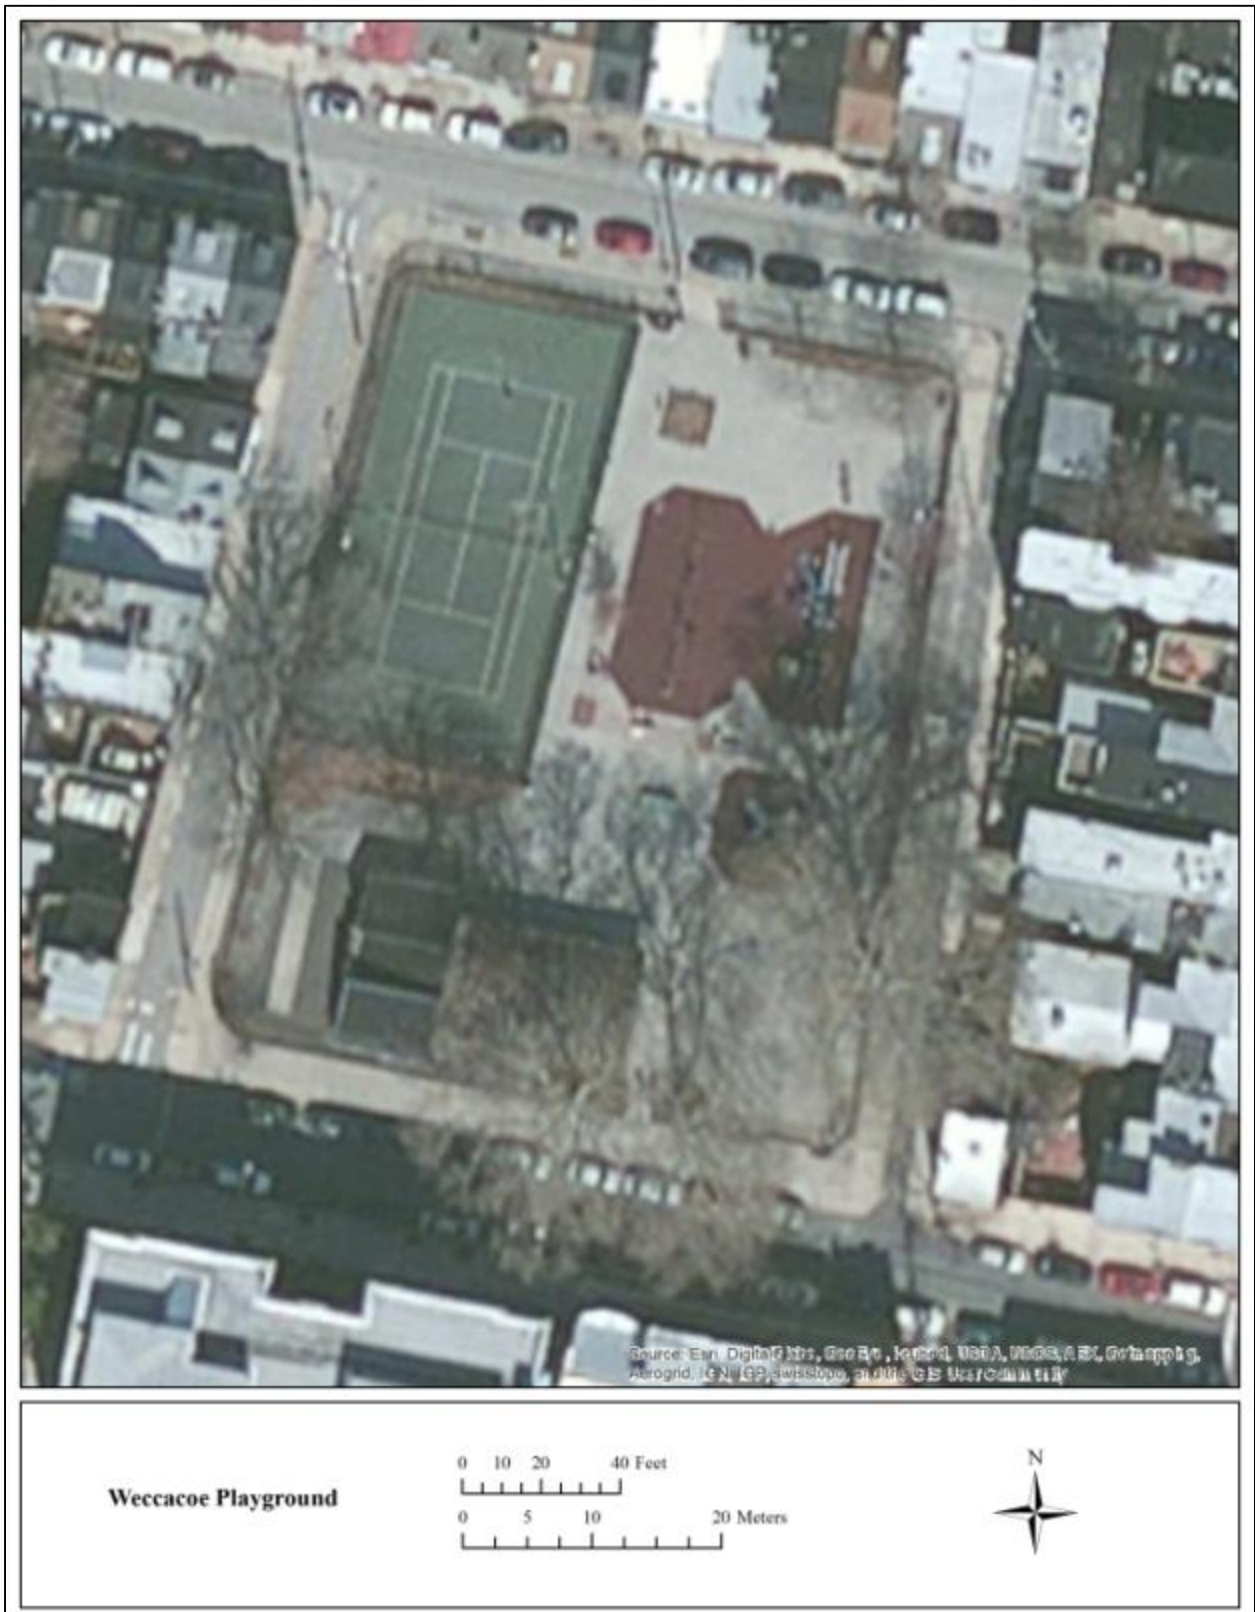
Figure 1.2 Satellite image of the Weccacoe Playground, showing existing conditions at the site.

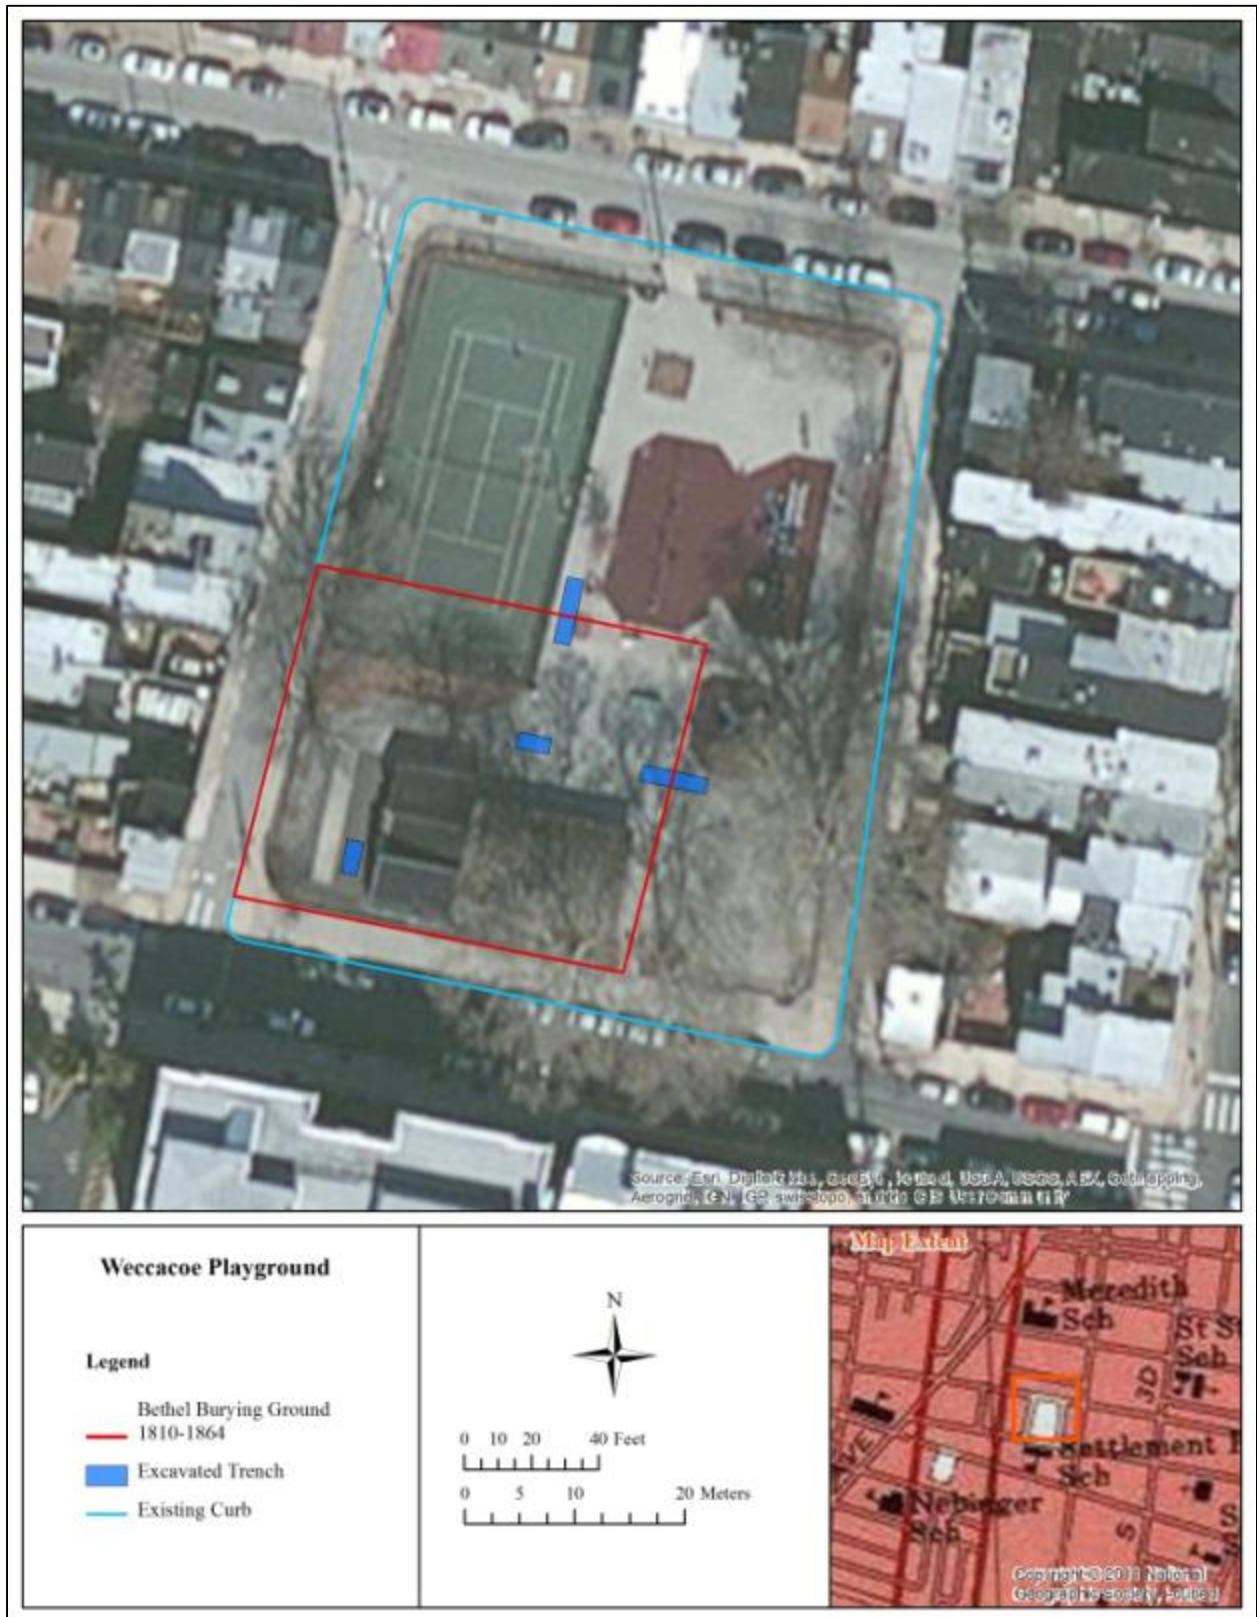
Figure 3.1 Site map showing the location of Phase IB trenches.

During the mechanical trenching, a small backhoe equipped with a toothless bucket removed the overburden from four locations across the historical burying ground. The location of each trench was first marked on the surface with spray paint, and the perimeter of each was cut with an asphalt saw prior the start of digging (Figures 3.2 and 3.3). Trenches were oriented north-south and east-west on an arbitrary grid that had been applied to the entire playground. Although off-cardinal direction (diagonal) trenches

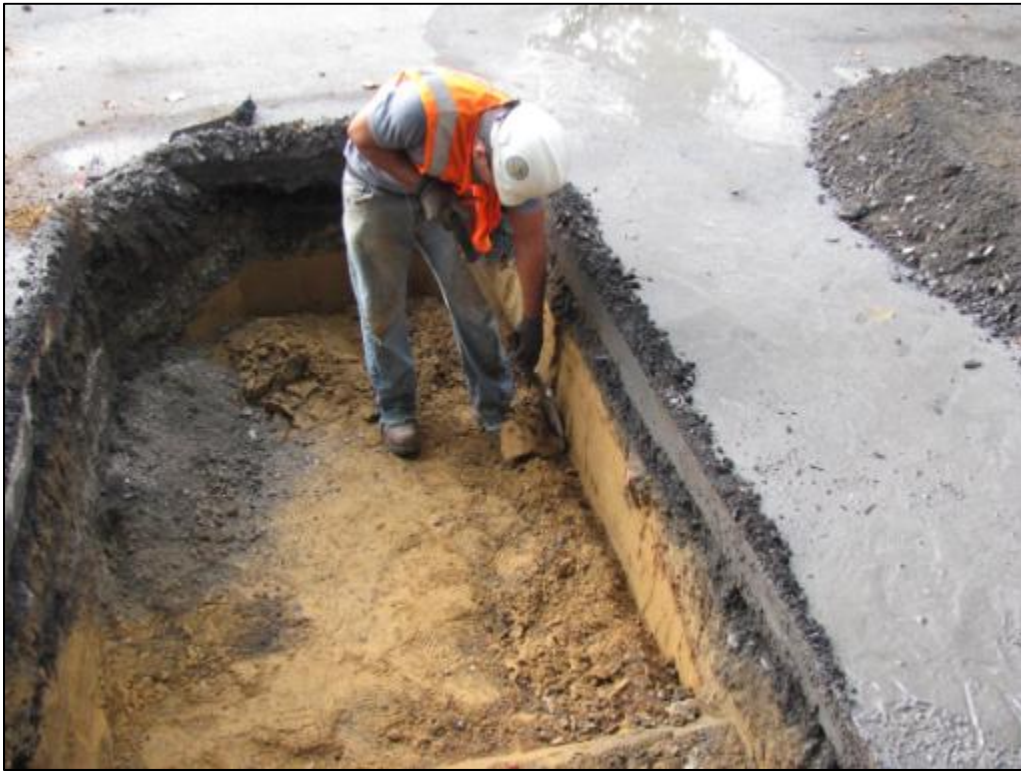
Figure 3.2 Cutting the trench profile.

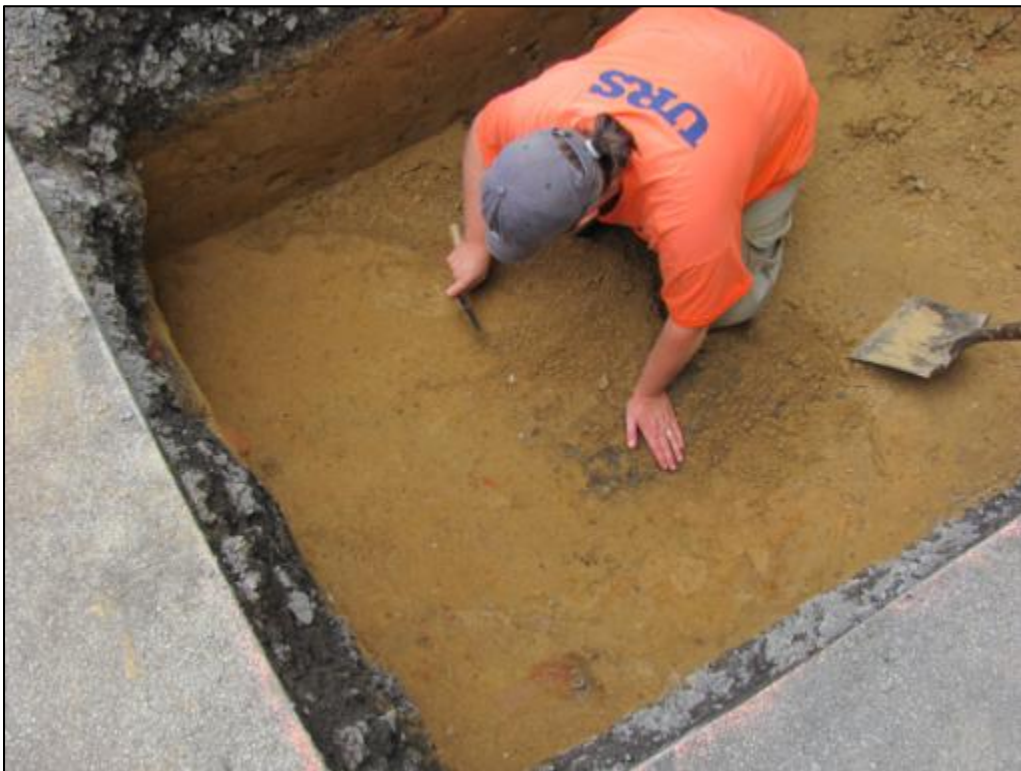
Figure 3.3 Hand excavating to define grave shafts.

Members of the archaeological team closely monitored all backhoe activity to ensure that intact burials were not disturbed in the process, and the mechanized excavation of each trench was terminated once the first evidence of burial features was identified. Once machine work was terminated, the floor and sides of each trench were excavated by hand in order to more clearly delineate burial features and the exposed stratigraphy. Excavated fill soils were not screened, but were thoroughly examined by hand, and diagnostic artifacts from each soil layer were retrieved, placed in labeled plastic artifact bags, and retained for possible further study. All exposed trench floors, side profiles, and exposed archaeological features were thoroughly documented on hand-drawn maps and by way of high-resolution digital photography (Figures 3.4 and 3.5).

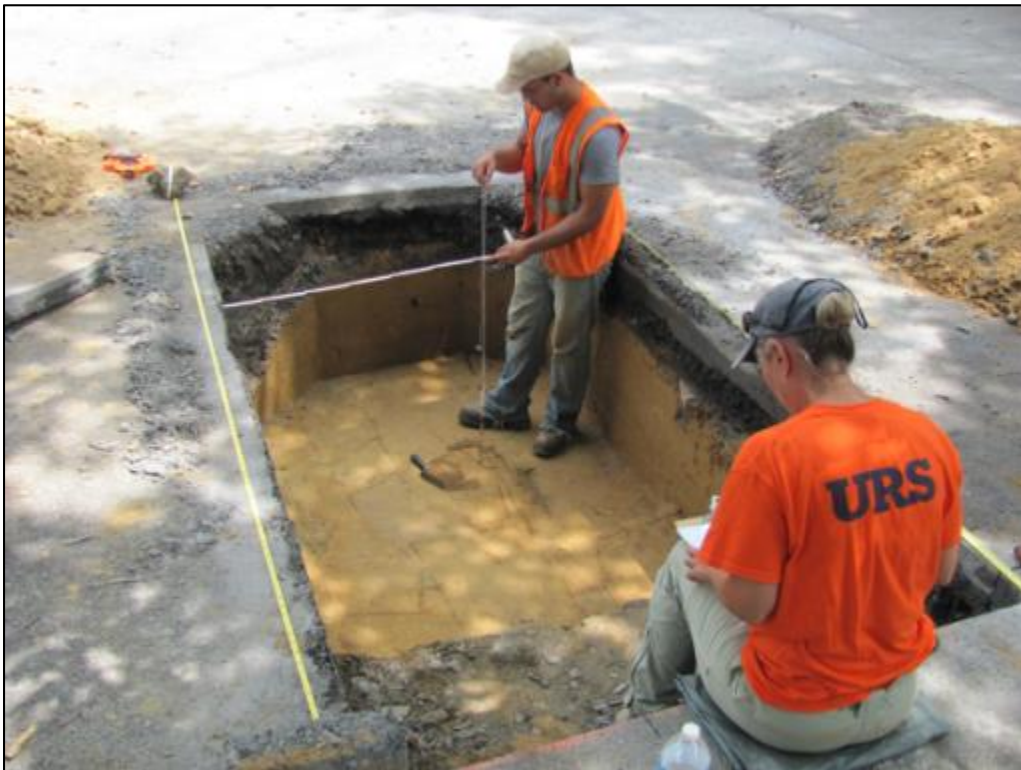
Figure 3.4 Mapping identified grave shafts in Trench 2.

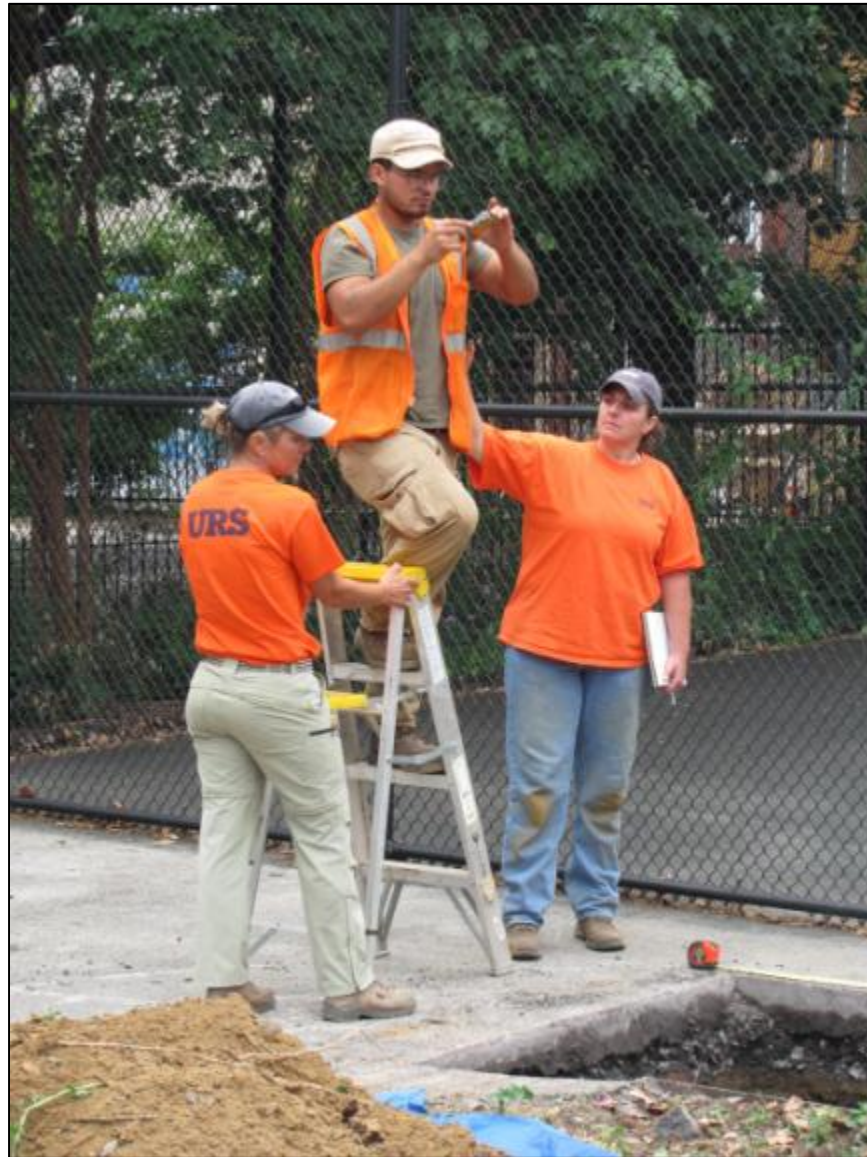
Figure 3.5 Photodocumenting findings from Trench 3.

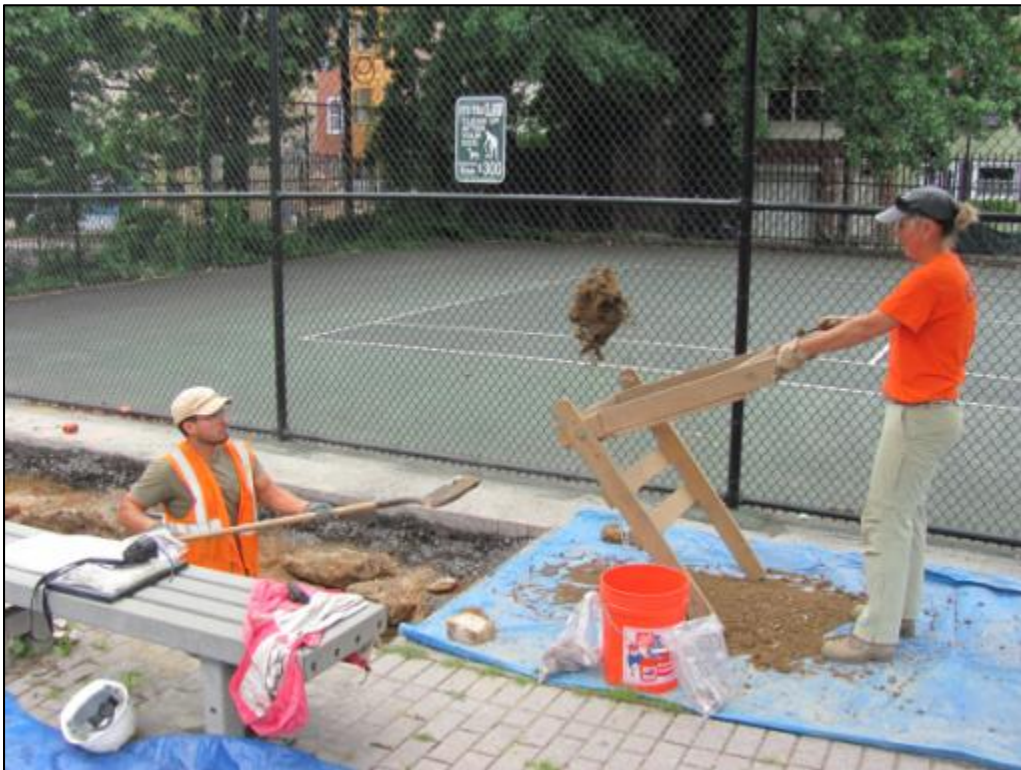
Figure 3.6 Screening soil excavated from EU 3 in Trench 3.

A total of three test pits were hand excavated within trench sections that extended into adjacent historic backyards bordering the cemetery. All (100%) soils removed from these tests were screened through ¼-inch hardware cloth to recover any artifacts present (Figure 3.6). Recovered artifacts were collected in labeled plastic bags and retained for further study and documentation. Test pit profiles were recorded on standardized field forms, through hand-drawn plan and profile maps, and via high-resolution digital photographs.

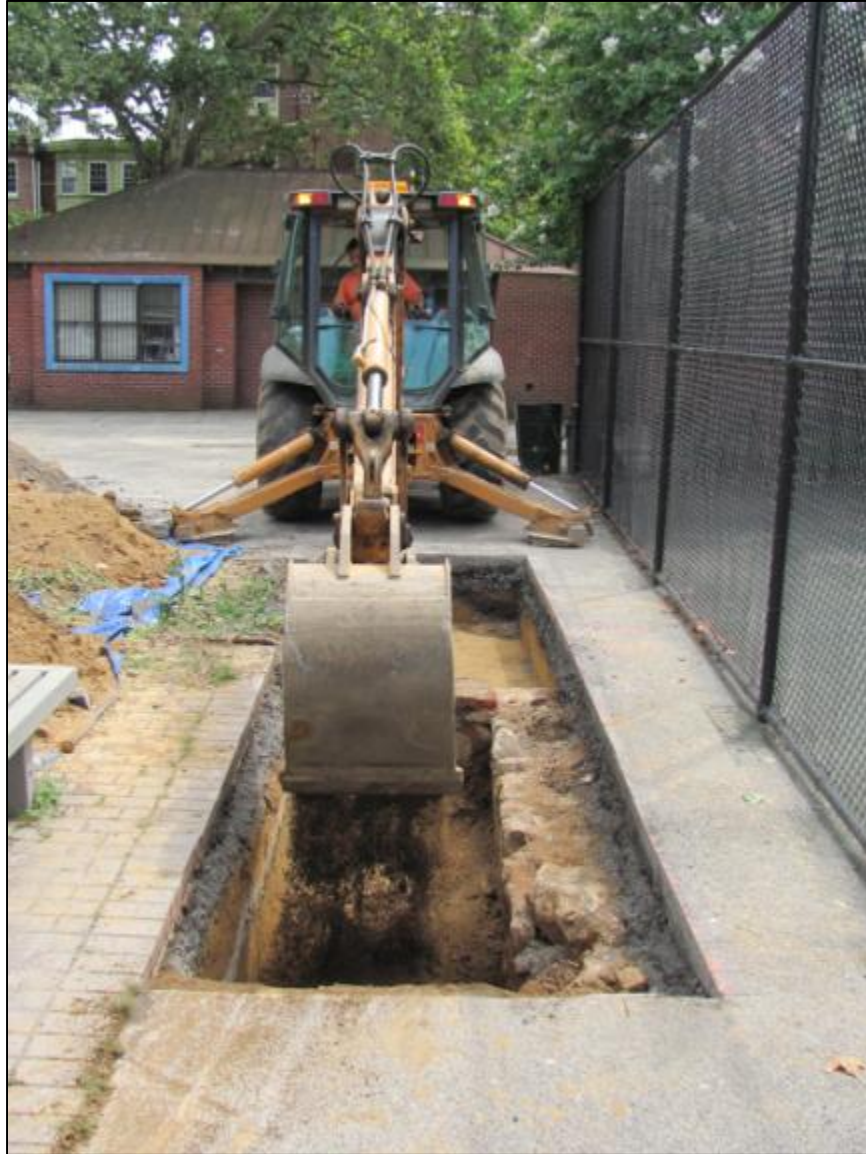
Figure 3.7 Backfilling a trench after excavation was complete.

Each trench was completely backfilled by the end of the work day on which it was opened in order to maintain a safe environment within the playground, as well as to ensure that no burials remains were disturbed during off-work hours (Figure 3.7). All trenches were mechanically compacted at the conclusion of fieldwork and sealed with asphalt patch before the site was evacuated on the last day.

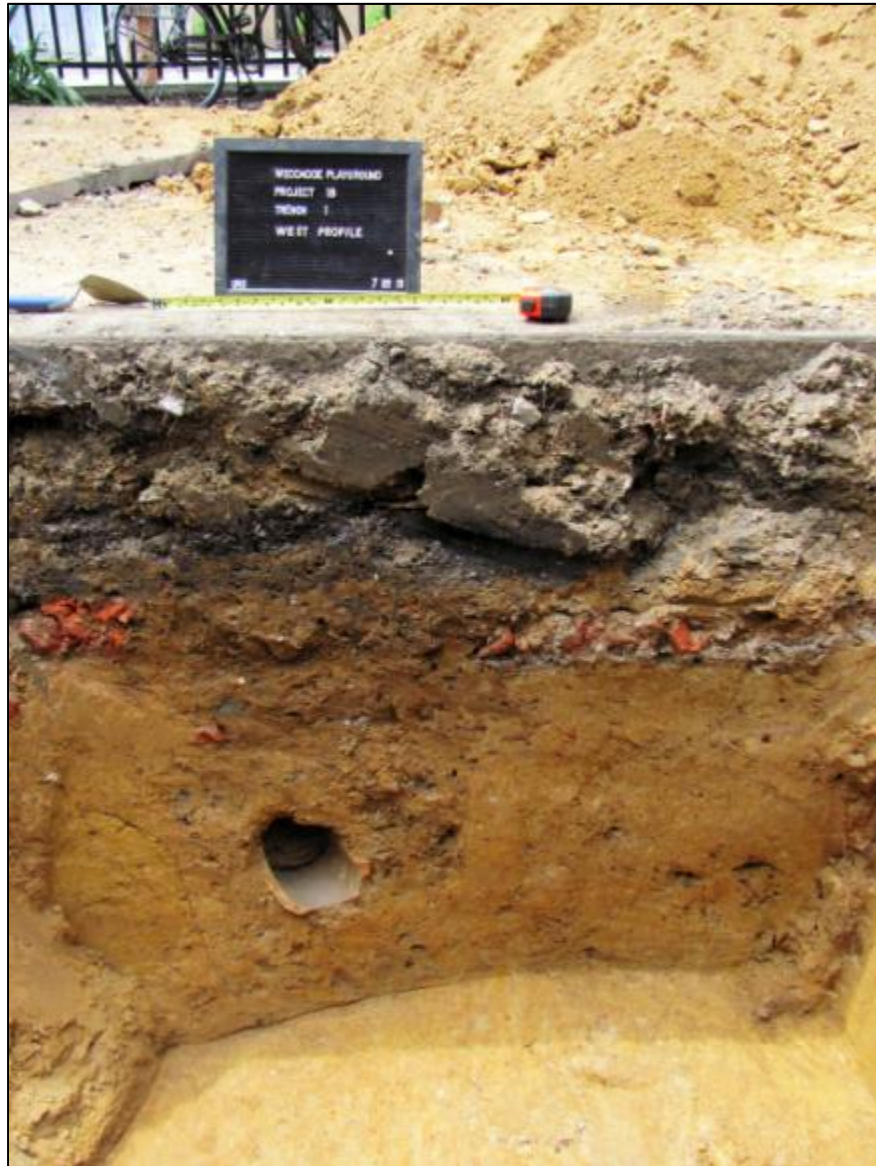
Figure 3.9 West profile of Trench 1, showing deep disturbance and terra cotta sewer pipe intrusion.

Below the asphalt and gravelly sub-base, excavation of the northern part of Trench 1 first encountered an approximately 1-foot-thick deposit of black-stained sandy fill containing dense brick rubble, blocky concrete, and asphalt. The removal of this fill exposed a second previously disturbed fill layer that extended to a depth of approximately 4.5 feet below the surface. This bottom fill deposit was itself disturbed by the installation of a terra cotta sewer pipe of unknown age (Figure 3.9). The 0.8-foot-diameter pipe was identified at a depth of approximately 4 feet below the surface, extended east-northeast across the trench, and sloped gradually downward from the Recreation Building toward Lawrence Street. It is presumed that this utility had not been active for many years, as the pipe was cracked and thoroughly filled with dry silt. The small trench in which the pipe was laid had generally vertical sides and a gently sloping floor, and had been backfilled with a mix of yellowish brown, very dark gray, and brownish yellow silt sand that contained many small brick and coal fragments.

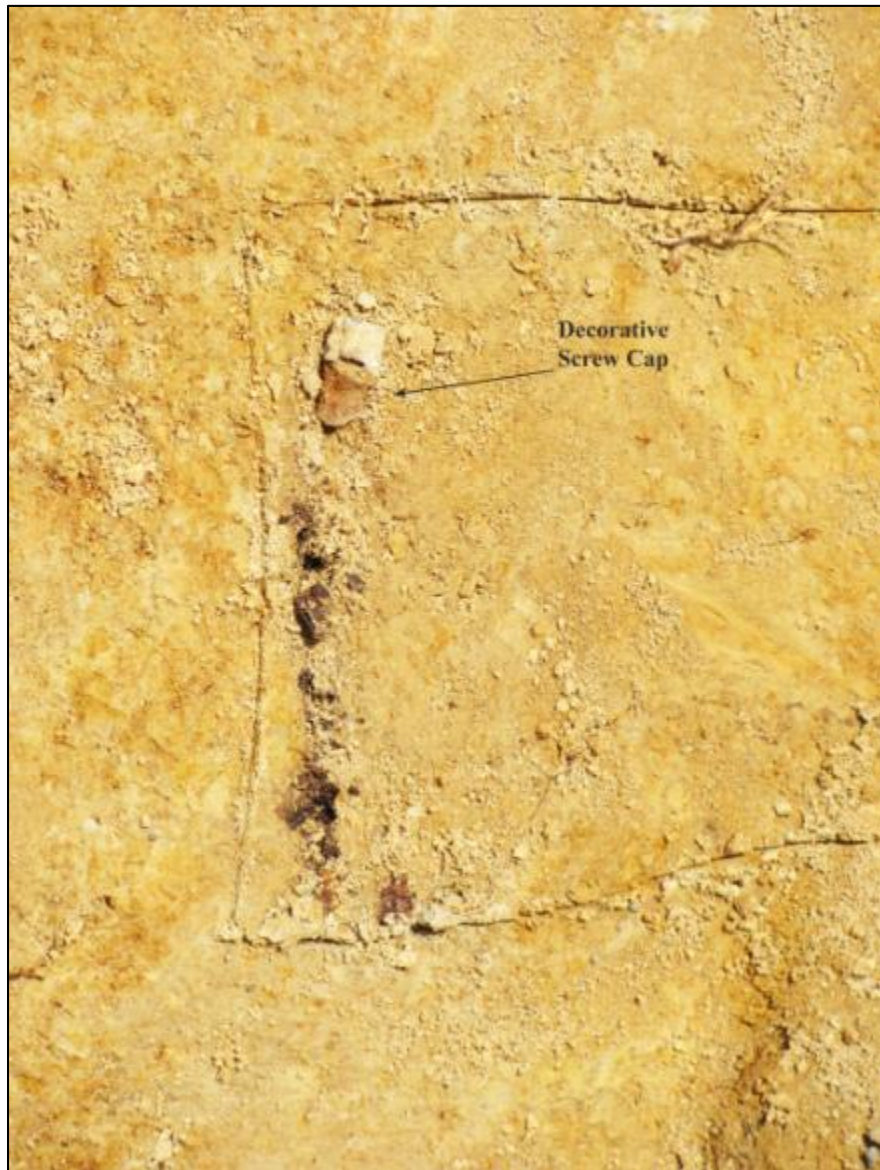
Figure 3.10 Detail of intact burial in Trench 1, showing decayed coffin wood and *in situ* decorative coffin lid screw caps.

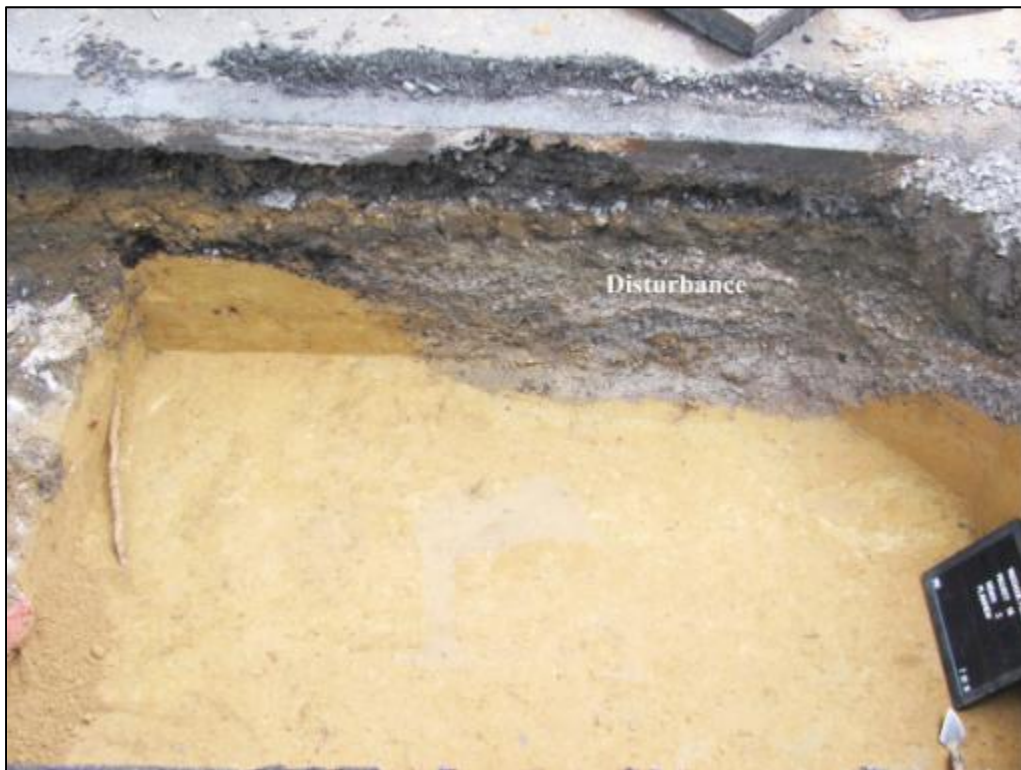
Figure 3.12 North profile of Trench 2, showing intrusive disturbance.

In addition to the utility conduit, Trench 2 also produced evidence of past disturbance within the cemetery. Along the northeast profile of the excavation, a large, steep-sided pocket of loose, dark gravel fill that was very similar to the overlying asphalt sub-base intruded to an unknown depth below the floor of the trench (Figure 3.12). The source of this disturbance is currently uncertain; however it is possible that it represents a repair of one of the “cave ins” or depressions appearing on the 1975 site plan (see Figure 2.15). It is not known whether or not this intrusion resulted in the disturbance of any intact burial remains, but, depending on its full depth, it is possible that it did.

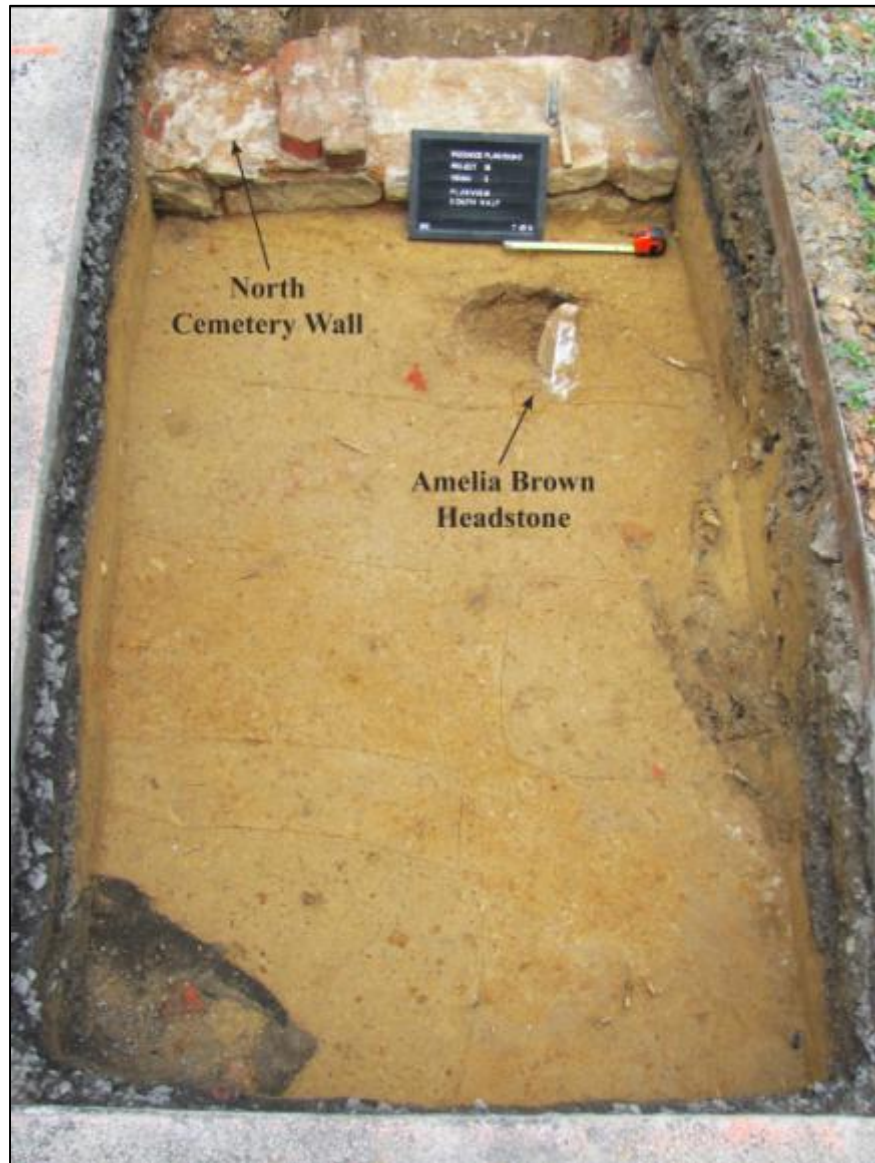
Figure 3.13 Overview of the south half of Trench 3, looking north, showing the north cemetery wall, identified grave shafts, and partial headstone.

**Southern Trench Section (Cemetery Associated).** The southern 7 feet of Trench 3 were contained within the historical burial ground boundary. Mechanical excavation exposed yellowish brown silt loam fill at a depth of 1.3 feet below the playground surface—slightly below the top of the stone cemetery wall. Machine excavation was halted at just 1.8 feet below the surface of the playground, when a number of grave shaft features became visible. Hand clearing of the trench floor eventually resulted in the identification of at least five distinct, and in some cases partially overlapping, grave shafts within this fill soil (Figure 3.13). As in previous examples, all delineated grave shafts were oriented along an east-west axis; however, in this case, excavation did not extend deep enough to expose any decayed coffin wood, coffin nails, or other intact funerary artifacts. No evidence of disturbances potentially associated with relocation efforts was identified.

In addition to the grave shafts, the backhoe also uncovered a marble headstone fragment along the eastern side of the trench, just south of the cemetery wall. When initially identified, the marker was standing more or less vertically in the ground, and it was first thought that it might have been completely intact. Further excavation around it, however, revealed that the headstone had previously broken in half above the base some unknown number of years after its installation, and had been evidently discarded within the upper fill soils at some later time. Careful investigation of this artifact confirmed that it was no longer in its original position, and did not mark any intact burial location. This fragment was represented by the entire upper half of the headstone, including the section bearing the full engraved epitaph (Figure 3.14); at the request of representatives from Mother Bethel, it was removed from the ground prior to backfilling the trench. Examination of this stone revealed it to be simply carved, with an inscription that read:

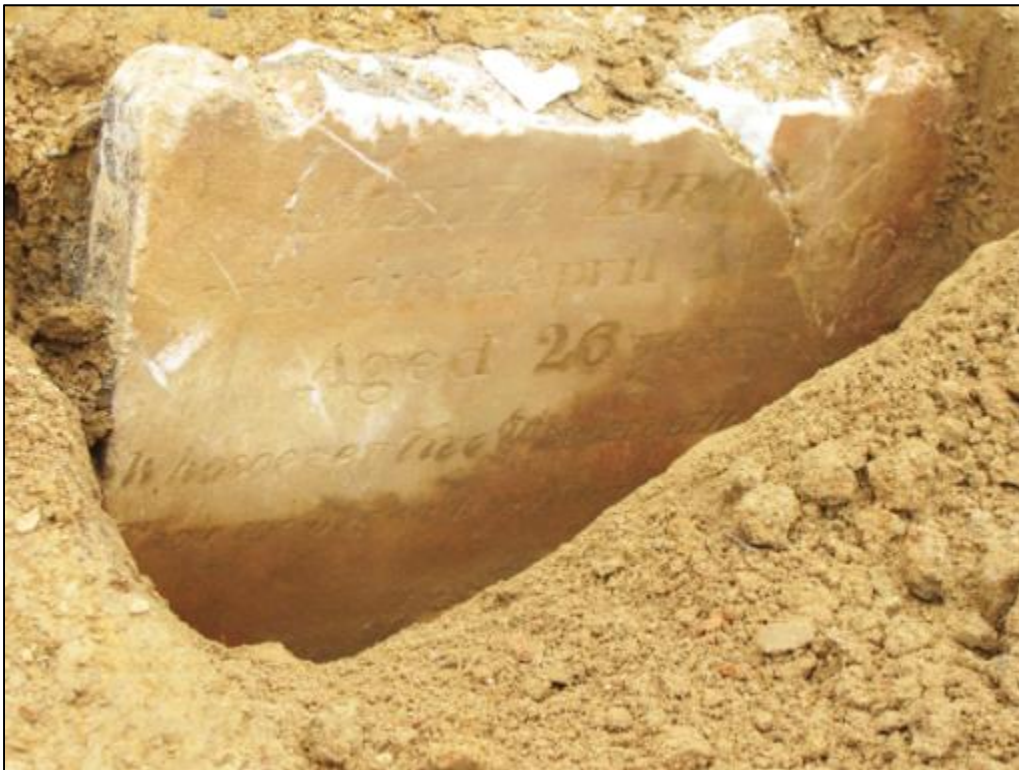
Figure 3.14 Detail view of Amelia Brown's headstone with preserved inscription.

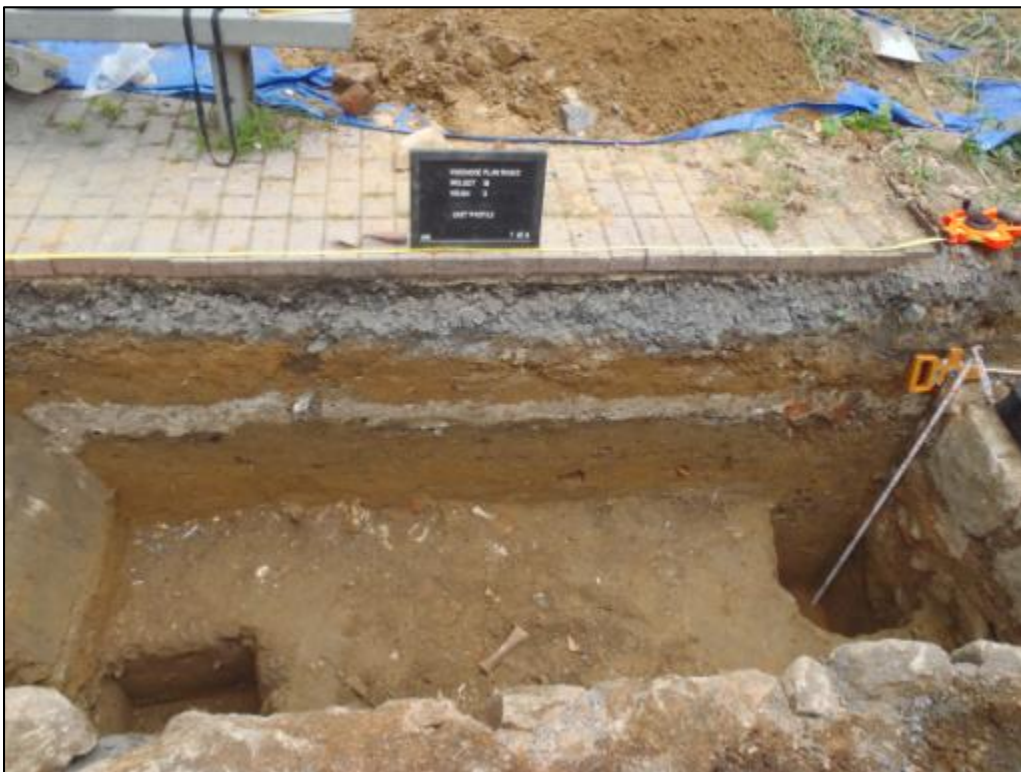
Figure 3.16 East profile of Trench 3, showing the identified fill sequence.

and ceramic historic artifacts. Excavated materials above this level were represented by stacked secondary fill deposits consisting of light gray mortar and brick, brown silt loam with brick and coal ash, and yellowish brown silt loam. None of these upper fills were observed to contain substantial quantities of artifacts (Figure 3.16).

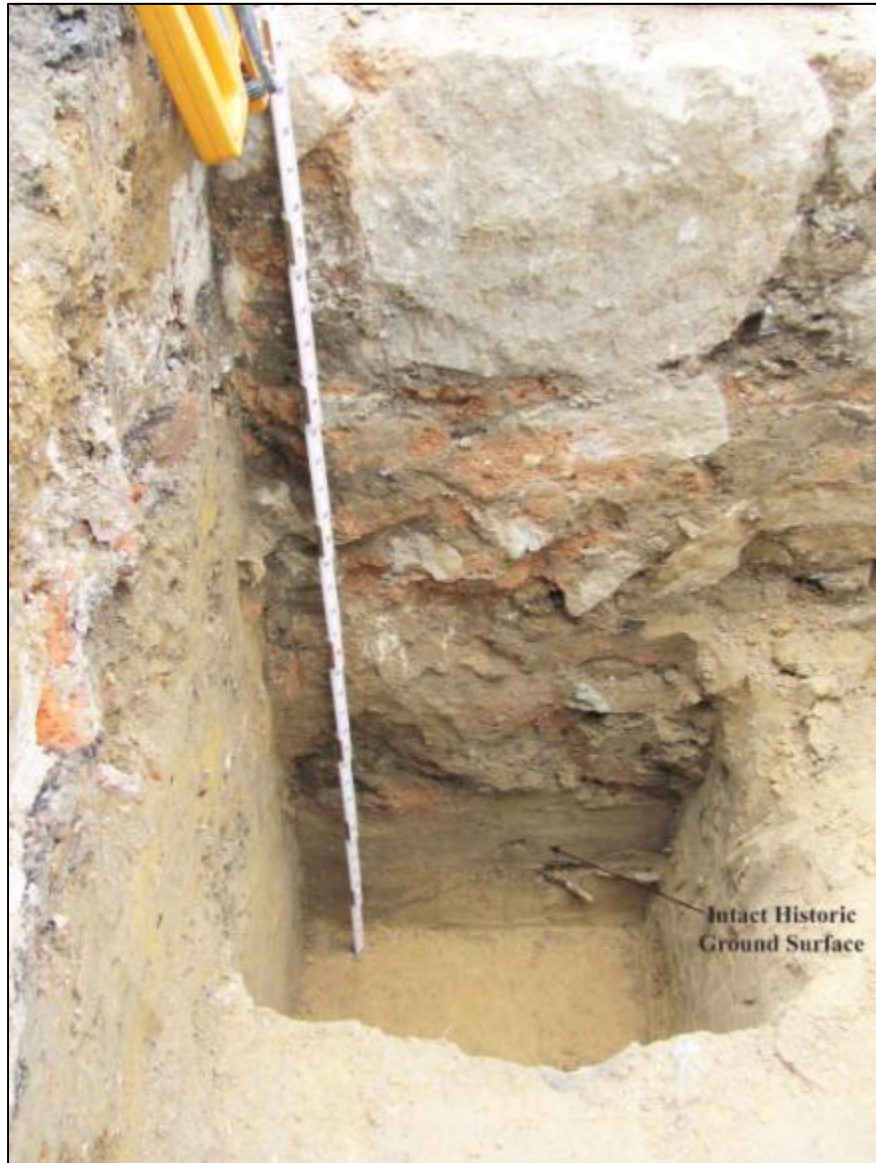
Figure 3.17 South profile of EU 4 in Trench 3, showing intact historic ground surface and undisturbed subsoil.

EU 4 was located immediately to the north of the cemetery wall and was excavated to a maximum depth of 5.2 feet below the surface of the playground. This test pit revealed a similar stratigraphy to that found in EU 3, including a midden horizon that extended to 4.5 feet bgs, an intact historic ground surface from 4.5–5 feet bgs, and undisturbed subsoil at the bottom (Figure 3.17). In addition to confirming that the historic ground surface to the north of the cemetery is situated more than 2 feet below the top of grave shafts to the south of the adjacent burial ground wall, EU 4's south profile also—and perhaps more importantly—revealed that the adjacent cemetery wall did not extend into the underlying subsoil. Instead, it terminated at the top of the historic ground surface. This finding indicated that the cemetery wall was almost certainly constructed at or about the same time that both the burial ground and the surrounding residential properties were filled in, and was primarily designed to retain the fill deposited on top of the cemetery's original ground surface.

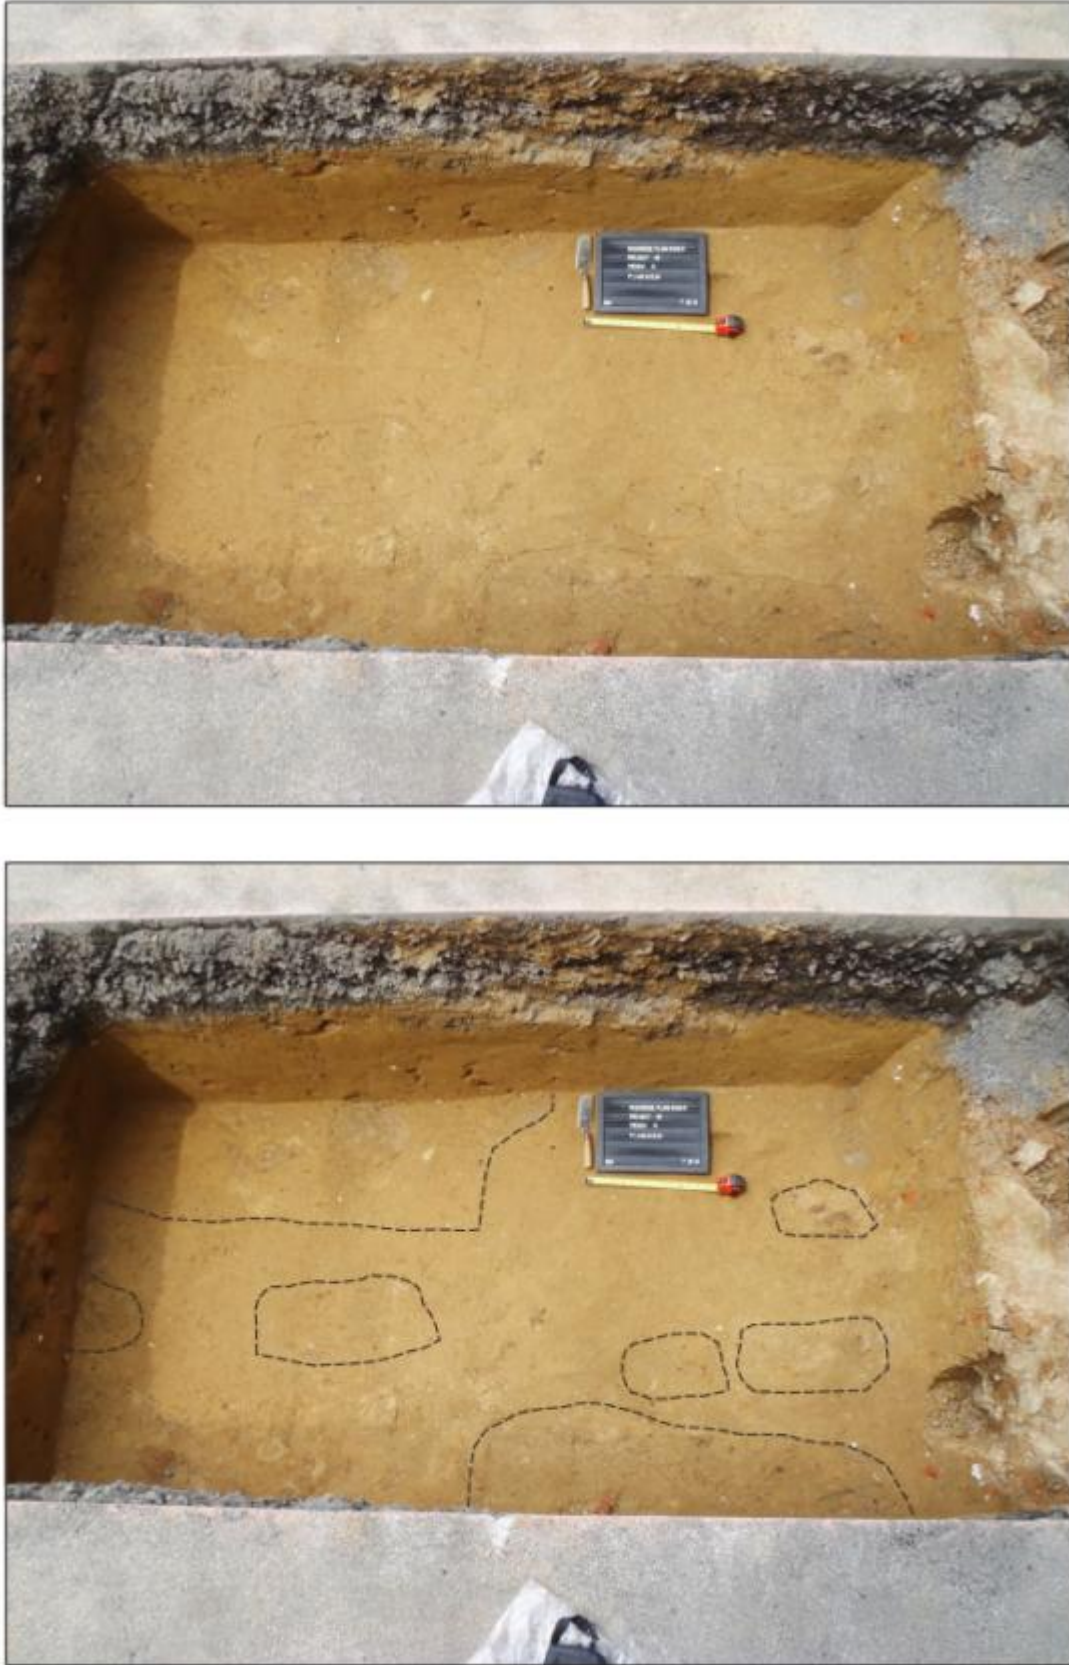
Figure 3.18 Overview of the west half of Trench 4, looking north, showing identified grave shafts and the east wall of the cemetery.

corner, the other shafts were, based on their size, likely associated with the graves of children. Four of the grave shafts delineated were extremely small and probably indicate the burials of infants or newborns. During the examination of two of the infant grave shafts, archaeologists uncovered traces of decayed coffin wood and associated coffin nails. This discovery indicated that this yellow brown fill layer contains not just evidence of grave shaft excavations, but also intact burial remains. Evidence of prior disturbance in this trench section was limited to an irregular rodent burrow at the western end of the excavation.

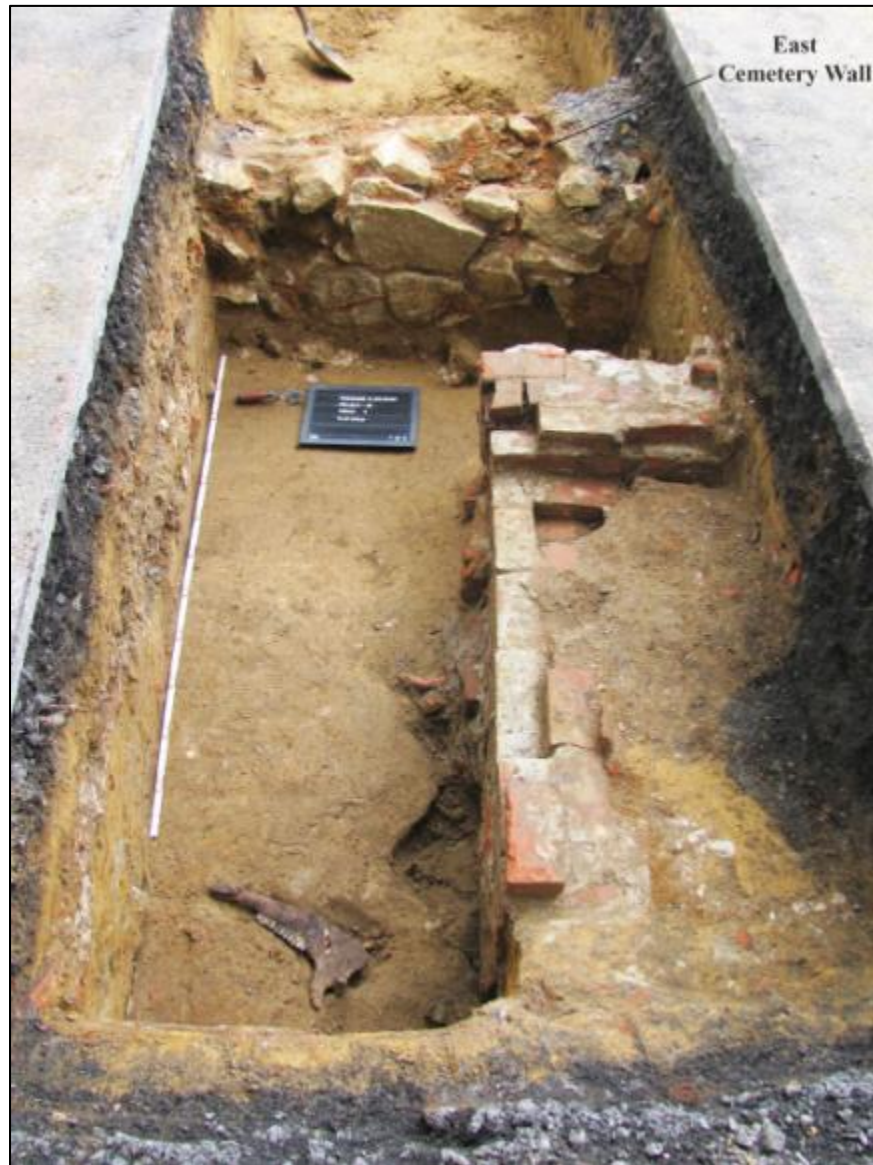
Figure 3.19 Overview of the east half of Trench 4, looking east, showing the east cemetery wall, residential brick structure, and exposed sheet midden deposits.

To the south of the brick structure, excavation encountered a highly mixed brown and dark yellowish brown fill deposit that was observed to contain brick, coal ash, fragmentary animal bone, and small quantities of glass and ceramic artifacts. At 3 feet bgs, excavations exposed a dark brown horizon with more concentrated sheet midden artifact deposits, and that appeared similar to the midden layer found in Trench 3. A single 2-foot-square test pit (EU 2)—located along the north trench profile, between the brick structure and the east cemetery wall—was hand excavated through the bottom of the trench in order to examine the underlying stratigraphy and to search for possible evidence of burial features. EU 2 was excavated to a maximum depth of 4.5 feet below the surface and, similar to EUs 3 and 4 in Trench 3, revealed a 0.6-foot-thick, intact historic ground surface (A horizon) below the midden layer, and below the historic surface, subsoil deposits (B horizon). The historic ground surface exhibited a gentle downward slope to the west and contained few historical artifacts. As in Trench 3, the historic ground surface identified in this backyard sat below the depth at which intact grave shafts were encountered on the opposite side of the cemetery wall (Figure 3.20). In this instance, the ground surface was identified approximately 1 foot below the delineated tops of adjacent grave shafts, and 2 feet below the top of the fill in which those grave shafts were contained.

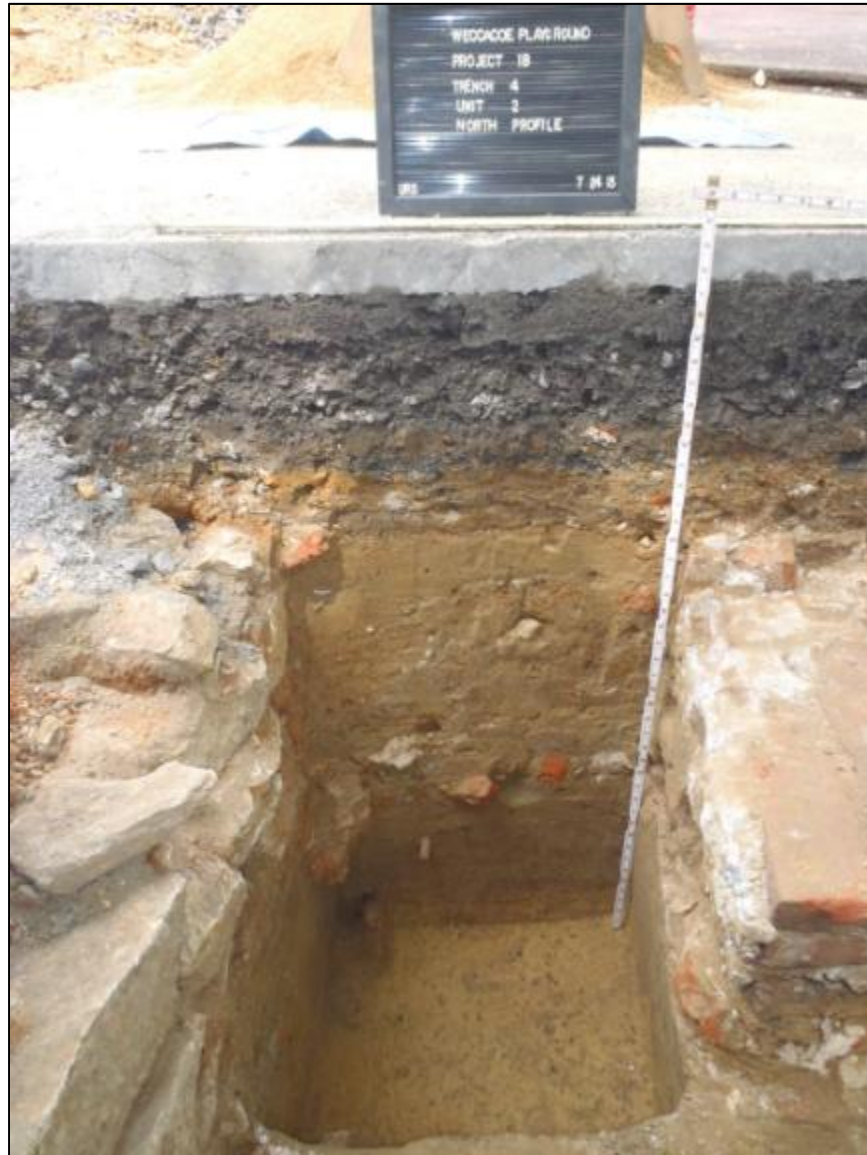
Figure 3.20 North profile of EU 2 in Trench 4, showing intact historic ground surface and undisturbed subsoil.
