Pennsylvania  
Horticultural  
Society

## Phase IB Archaeological Investigations of the Mother Bethel Burying Ground, 1810 – Circa 1864

ER No. 2013-1516-101-A

**URS**

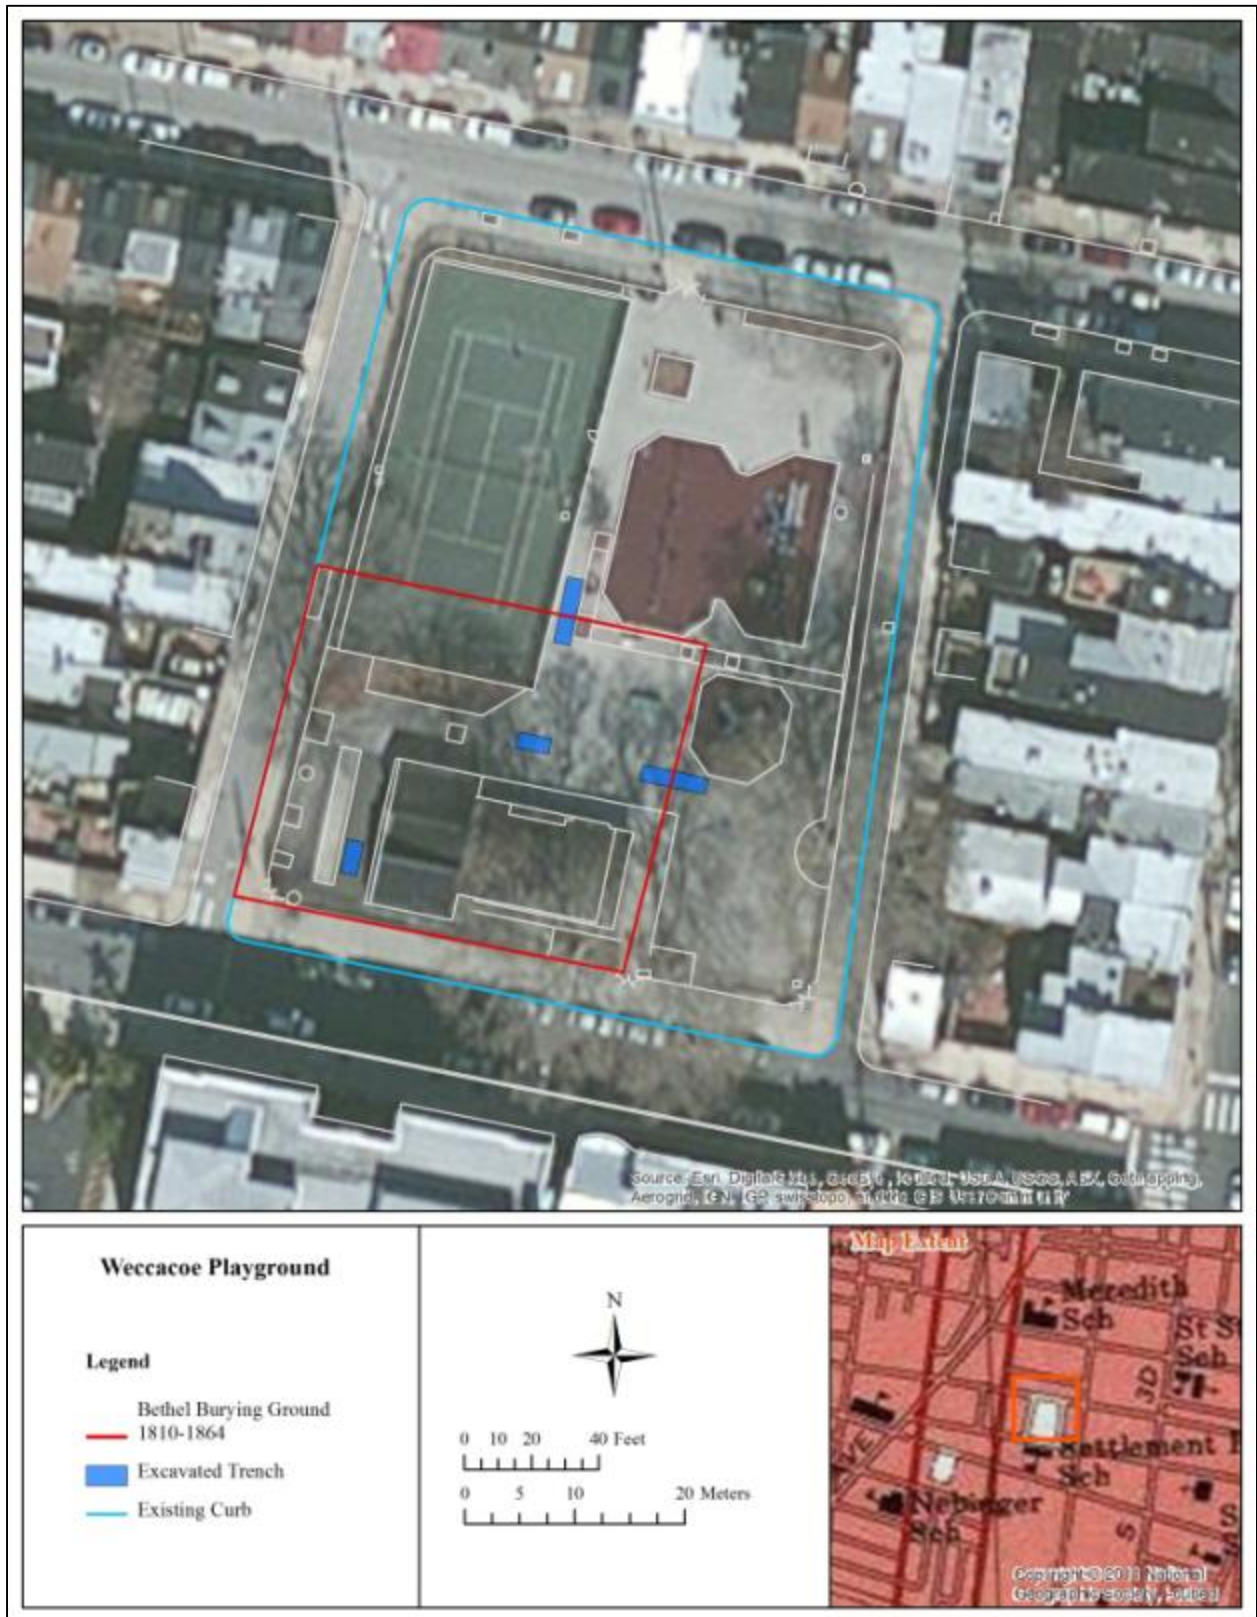
Figure 4.1 Current site plan, showing the location of Phase IB trenches and the mapped boundaries of the Mother Bethel Burying Ground.

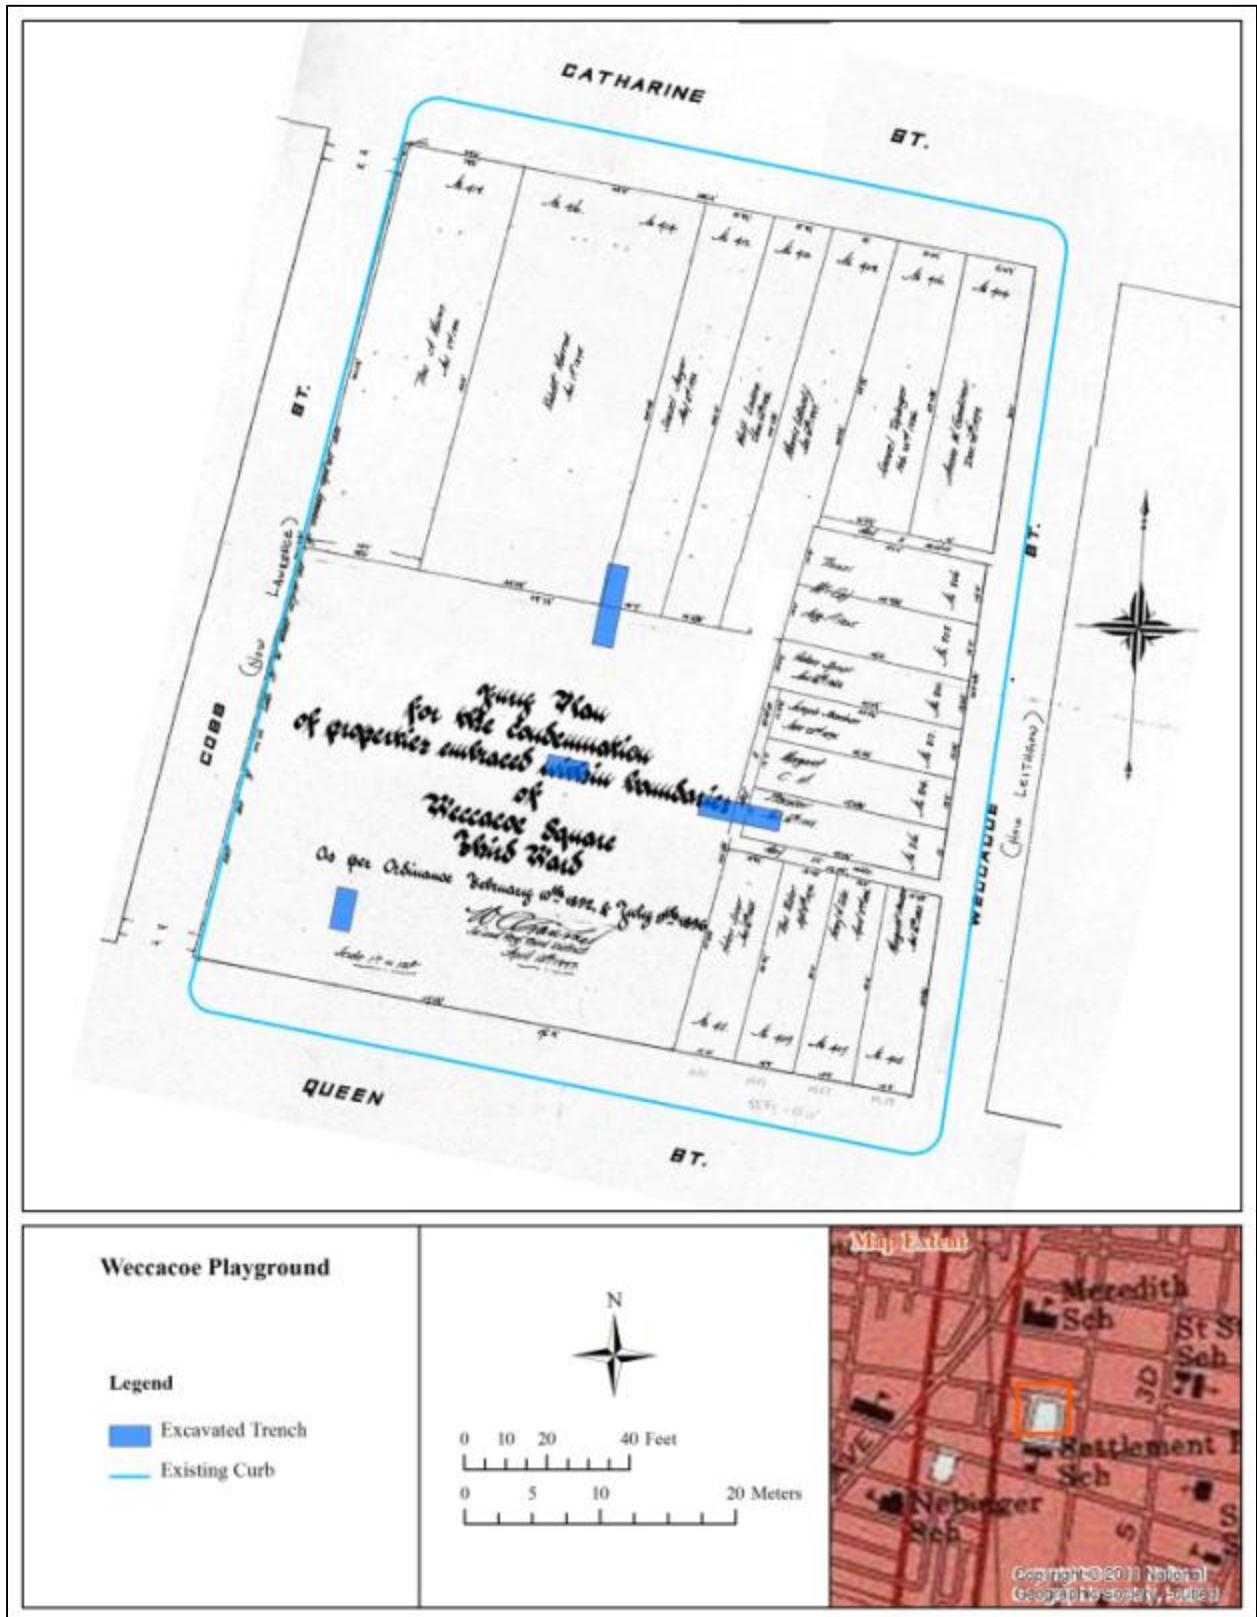
Figure 4.2 Map showing the location of Phase IB trenches with respect to the identified cemetery walls and adjacent historic house lots.

Lastly, while the detailed analysis of historic artifacts from the backyard portions of Trenches 3 and 4 is beyond the scope of this investigation, some interpretations will be offered. The north section of Trench 3 fell within the rear yard of the house at 412 Catharine Street (Figure 4.2). It is believed that the stone foundation wall uncovered along the west wall of that trench was associated with a small frame structure of unknown function built at the back edge of the property during the nineteenth century. The presence of buildings in this general location are suggested on the 1849 Sydney map, and it is presumed that this structure was likely built around that time. It is interesting to note that this foundation was not picked up
