# Evaluation of the Chestnut Street Art Shelters

# Chestnut & 12<sup>th</sup> St. Shelter

**NORTHEAST FENCE & IRON WORKS, INC.**

**Re: Condition assessment and treatment recommendations for the 12<sup>th</sup> Street Bus Shelter Artwork**

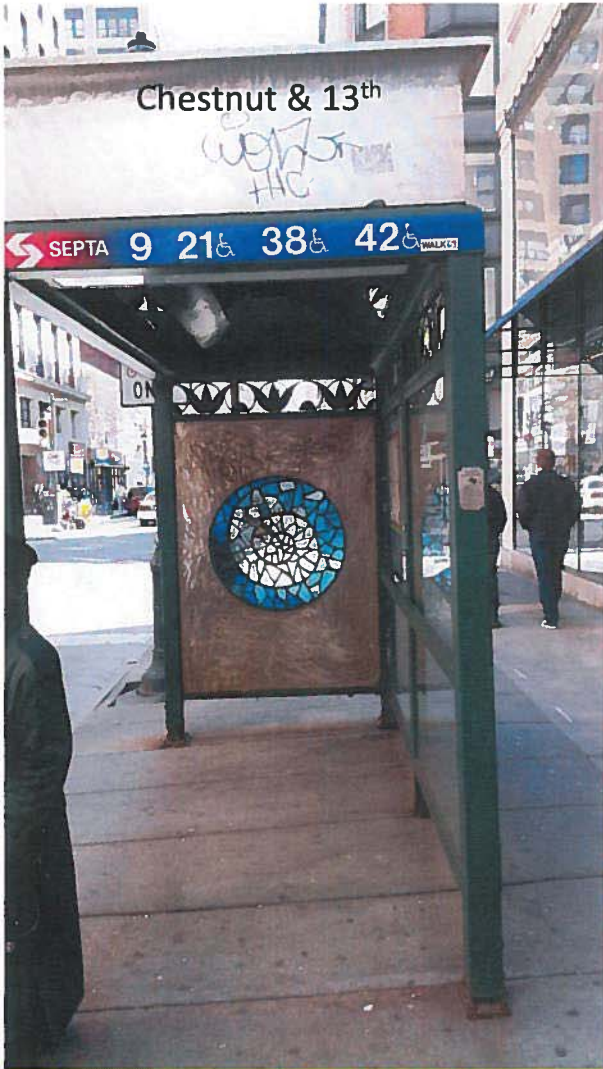
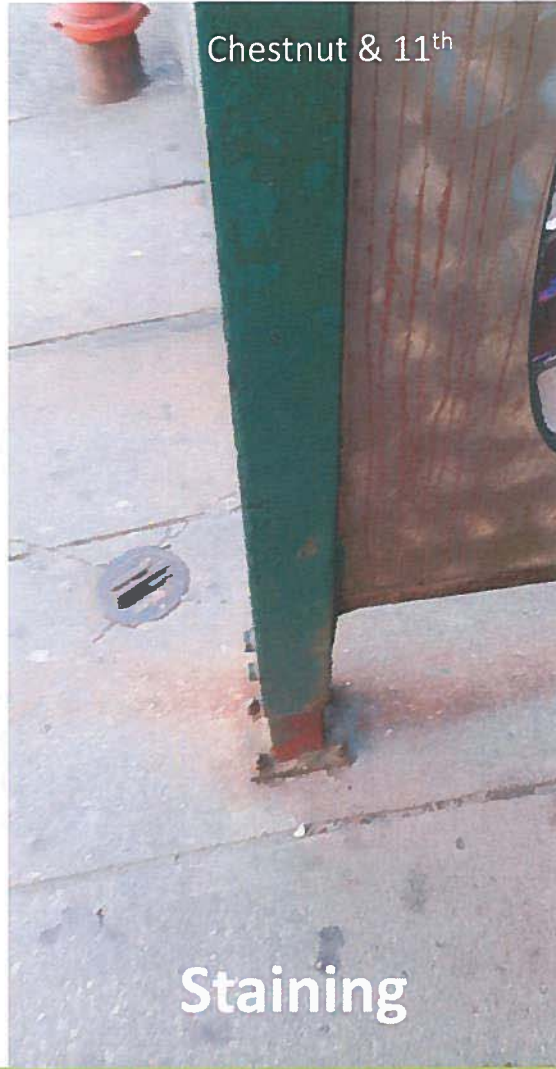
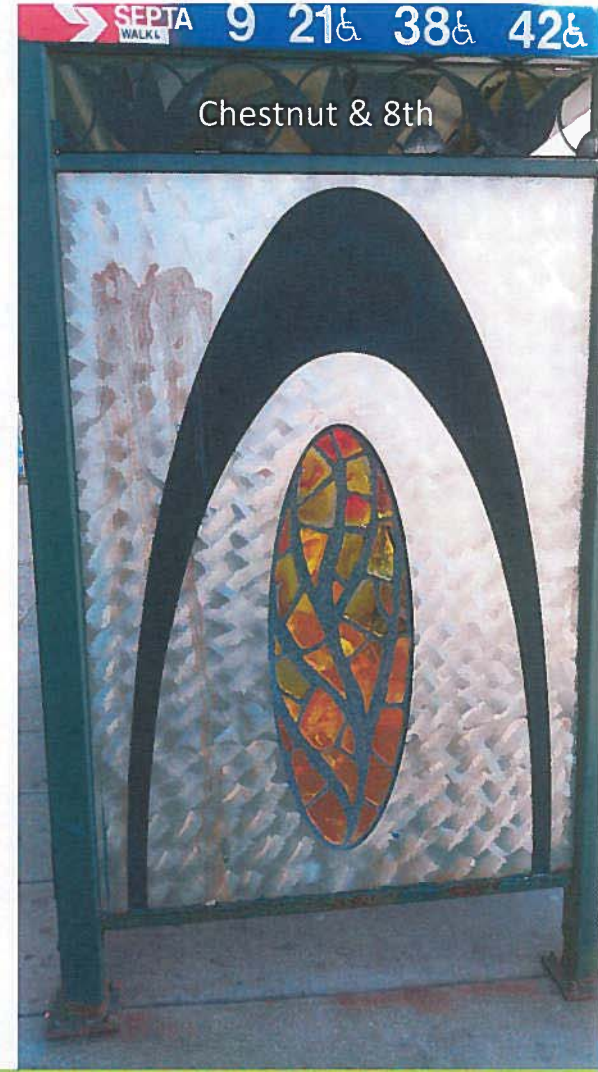
**Staining**

Typical condition of the Art Shelters

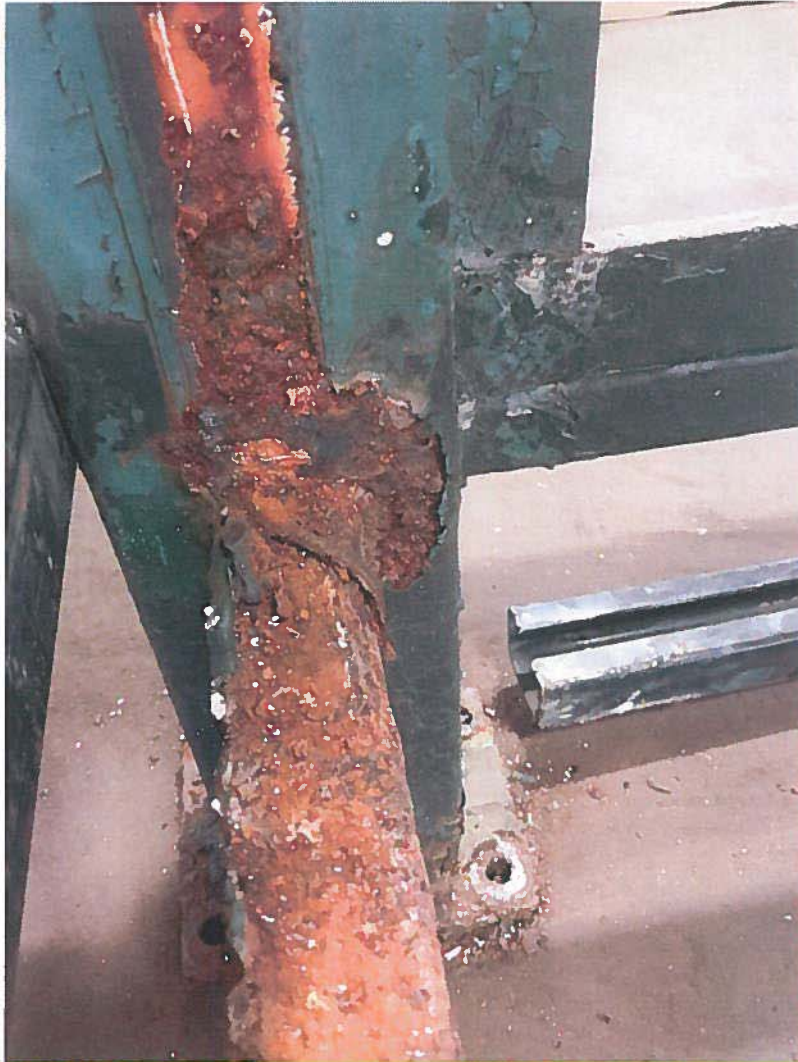
***Rusting of weep  
holes allowed for  
water and debris  
to fill legs***

The four main support columns were filled with water, rust and debris. See attached pictures of column bases.

The main support structure should be replaced due to rusting and should be fabricated from either galvanized steel or stainless steel to remedy the possibility of structural failure. The existing drainage design has failed and is basically just allowing water to completely fill the structural support columns. This should be remedied via column drainage holes and elbows being placed in the drainage tube bases allowing for proper water run-off.

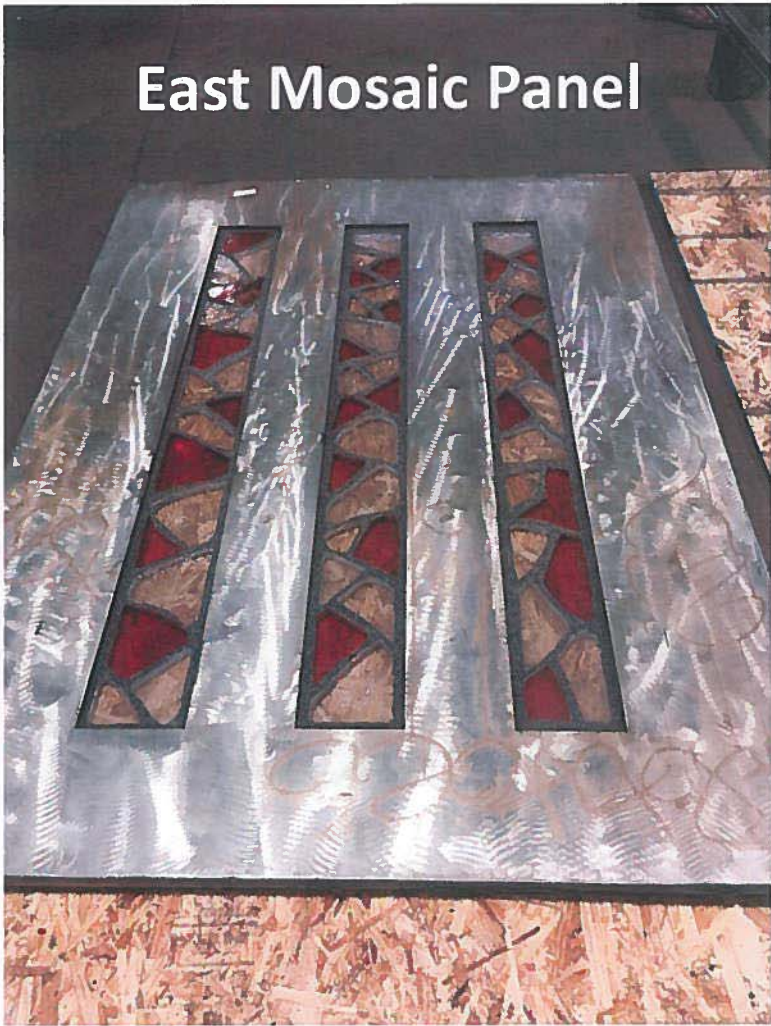
**East Mosaic Panel**

**Condition:** Substantial areas of the metal surface have halos of old graffiti. The glass and embedment material for the glass is soiled. There is cracked, broken and missing glass in one section. Other areas also have cracked glass but this appears to be an intentional aesthetic. There are no noticeable problems on the exterior of the panel. The interior was not accessible.

**Treatment:** Remove graffiti with a chemical cleaning solution. If etching of the surface is discovered, resurface the metalwork.  
Replace the damaged piece of glass with matching material.  
Clean soiling from the glass and embedment material.  
Clean the edges of the panel of all old sealant material.

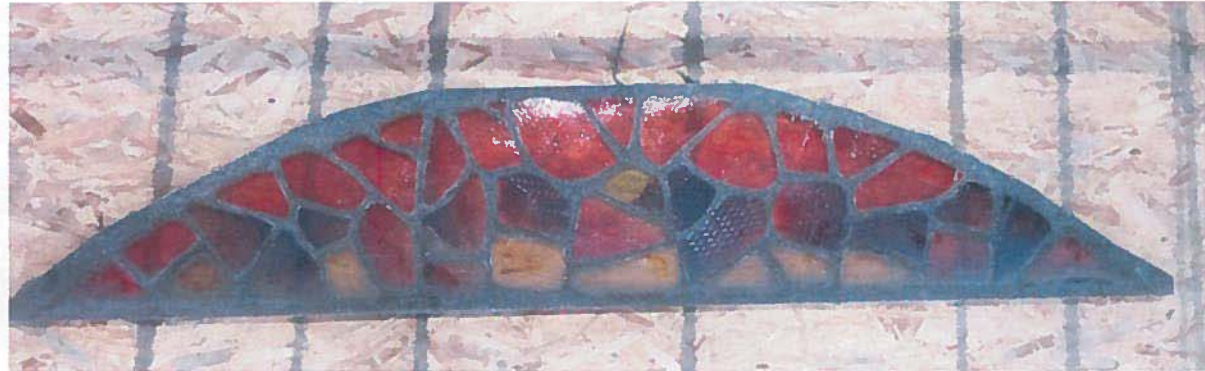
**Fanlight**

**Condition:** The glass and embedment material are soiled. The glass is cracked in some areas, but this appears to be an intentional aesthetic.

**Treatment:** Clean soiling from the glass and the embedment material.

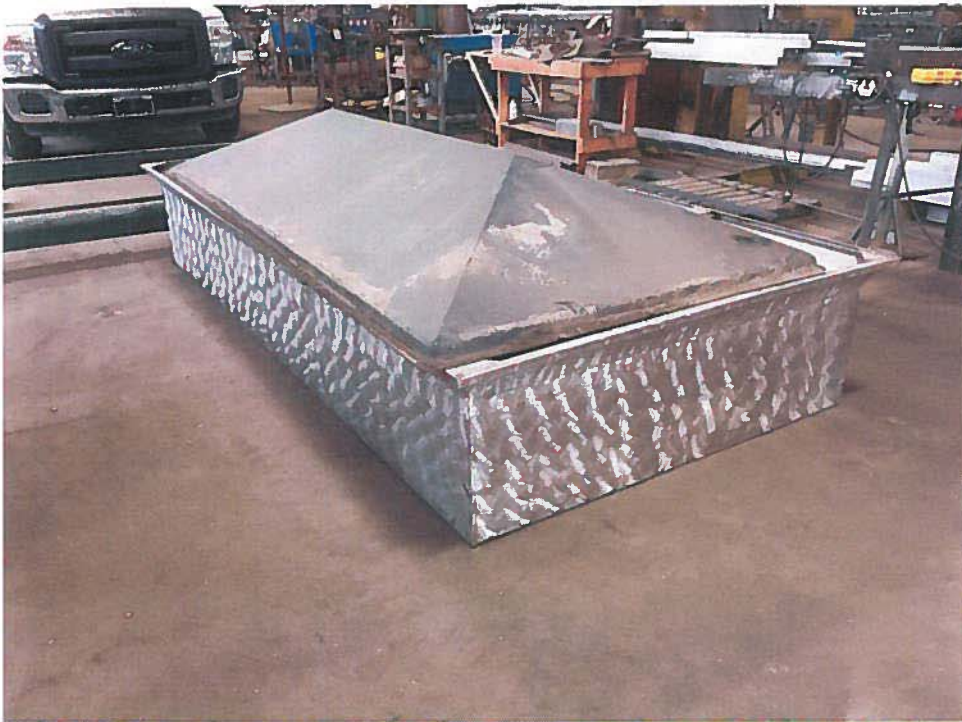
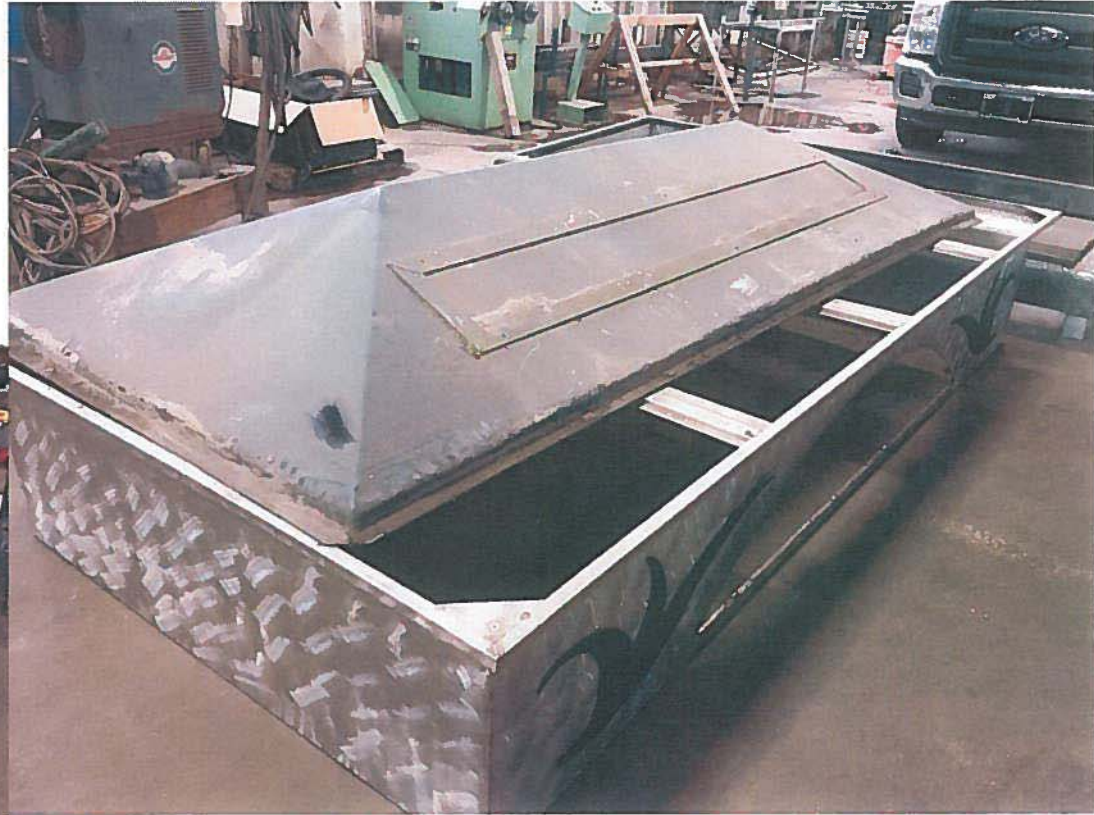
## The Cap

**Condition:** The cap is generally in good condition but the painted finish on the north side detailing is chalking. The stainless steel is soiled but in good condition.

**Treatment:** Clean the surface to remove soiling. Remove the paint finish to prepare the surface for refinishing. Apply a high-performance paint system including a rust-inhibiting primer and two-coats of finish paint.

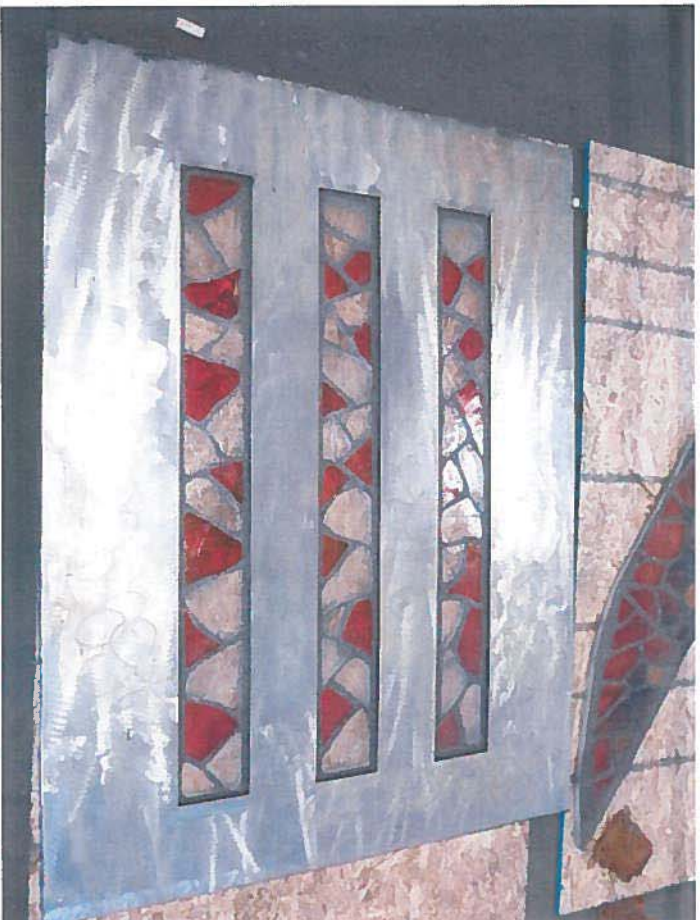
*Stainless steel panel with the glass mosaic inset*
